Appendix 3-D. Interconnected Surface Water Sustainability Management Criteria

13 **LOWER SHASTA RIVER WATER BALANCE: SEPTEMBER 2016**

LOWER SHASTA RIVER WATER BALANCE: SEPTEMBER 2016

MIDDLE SHASTA RIVER WATER BALANCE: SEPTEMBER-OCTOBER 2017

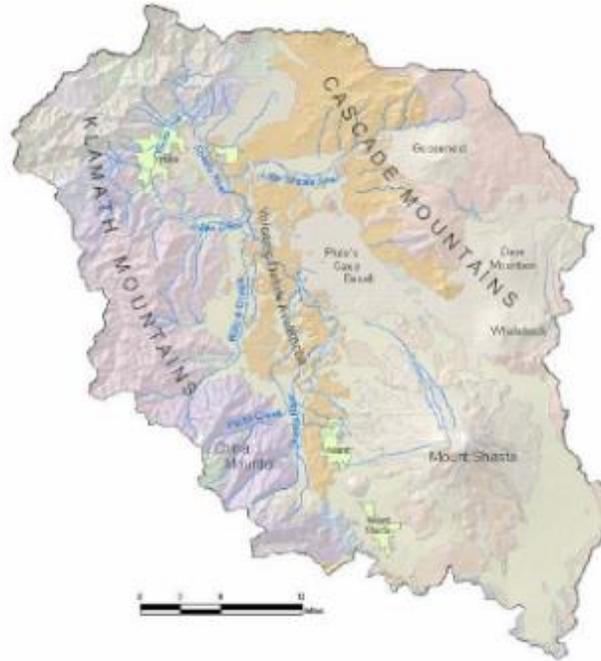
FIGURE 1. GEOLOGIC MAP OF THE SHASTA VALLEY. GRAPHIC FROM: (CALIFORNIA DEPARTMENT OF WATER RESOURCES, 2008)

The Shasta Valley is the meeting point of multiple tremendous geological forces that collectively create and complicate the hydrology studied in this document. To the west, the Klamath Mountain Terrane forms the western edge of the Shasta Valley, with elevations reaching up to 10,000 ft. These mountains are the visible result of the subduction of the Pacific Plate beneath the North American Plate with that subduction process scraping off a variety of ocean sediments and island arcs which now form the Klamath Mts. In addition, that subduction process has contributed to multiple uplift events, created faults, and ultimately set the stage for the geologic processes on the east side of the valley, where volcanic eruptions in the Western Cascades prevail, and have created Mt. Shasta, Whaleback, Deer Mt., and Goosenest, collectively forming the eastern edge of the Shasta Valley. The bulk of the visible surface of the Shasta Valley is comprised of volcanic materials overlying the deeper ocean sediments forming the underlying Hornbrook formation. Those volcanic deposits most notably include an extensive lahar or debris avalanche (~350,000 years before present), forming the bulk of the relatively flat central portion of the Shasta Valley, and the Plutos Cave Basalt (~100,000-300,000 years before present in the southwesterly portion of the valley, comprised of a fractured surface and subsurface lava formation that serves to transmit the bulk of the water that ultimately discharges as springs to form the flows constituting the Shasta River investigated in this study. Lesser portions of the Shasta Valley include more recent alluvial deposits around its perimeter, derived from the surrounding mountains. These geologic features are displayed in Figure 1 and related hydrologic zones in Figure 2.

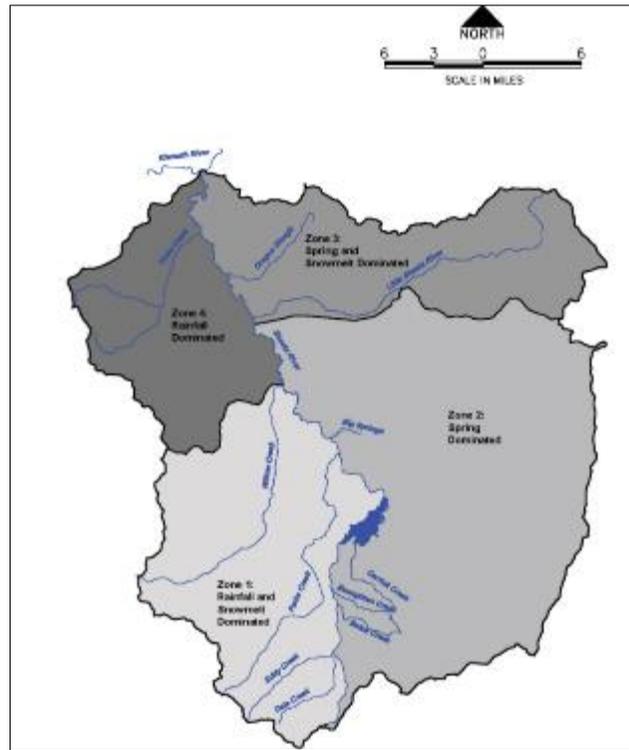
FIGURE 2. HYDROLOGICAL ZONES IN THE SHASTA BASIN BASED ON THE DOMINANT HYDROGRAPH COMPONENTS THAT DETERMINE RUNOFF PATTERNS IN THE MAINSTEM SHASTA RIVER. BOUNDARIES ARE APPROXIMATE. GRAPHIC FROM: (Mcbain & Trush, Inc et al. 2010).

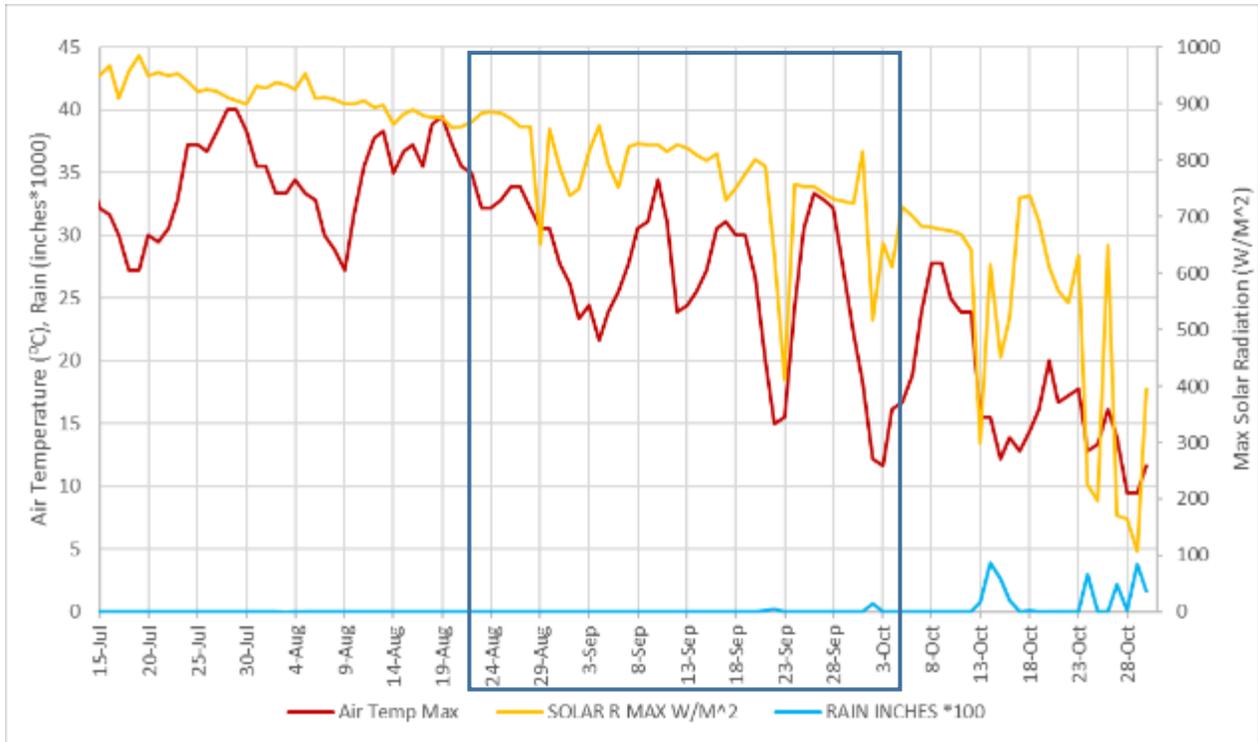
Within the assessment area, there are two meteorological stations, one at the Weed Airport (WED) which is available through California Data Exchange Center (CDEC) and operated by CAL Fire and the second at Brazie Ranch which is available through the Western Regional Climate Center's Remote Automatic Weather Stations (RAWS) and operated by S&PF. Air temperature, precipitation, and solar radiation data was analyzed from WED due to its closer proximity to the study area. These data are displayed below in Figure 3.

FIGURE 3. METEOROLOGICAL DATA INCLUDING MAXIMUM AIR TEMPERATURE, SOLAR RADIATION, AND PRECIPITATION DURING LATE SUMMER AND FALL 2016 WITH STUDY PERIOD HIGHLIGHTED. DATA SOURCE CDEC STATION WED (WEED AIRPORT): JULY 15, 2016 - OCT. 31, 2016.

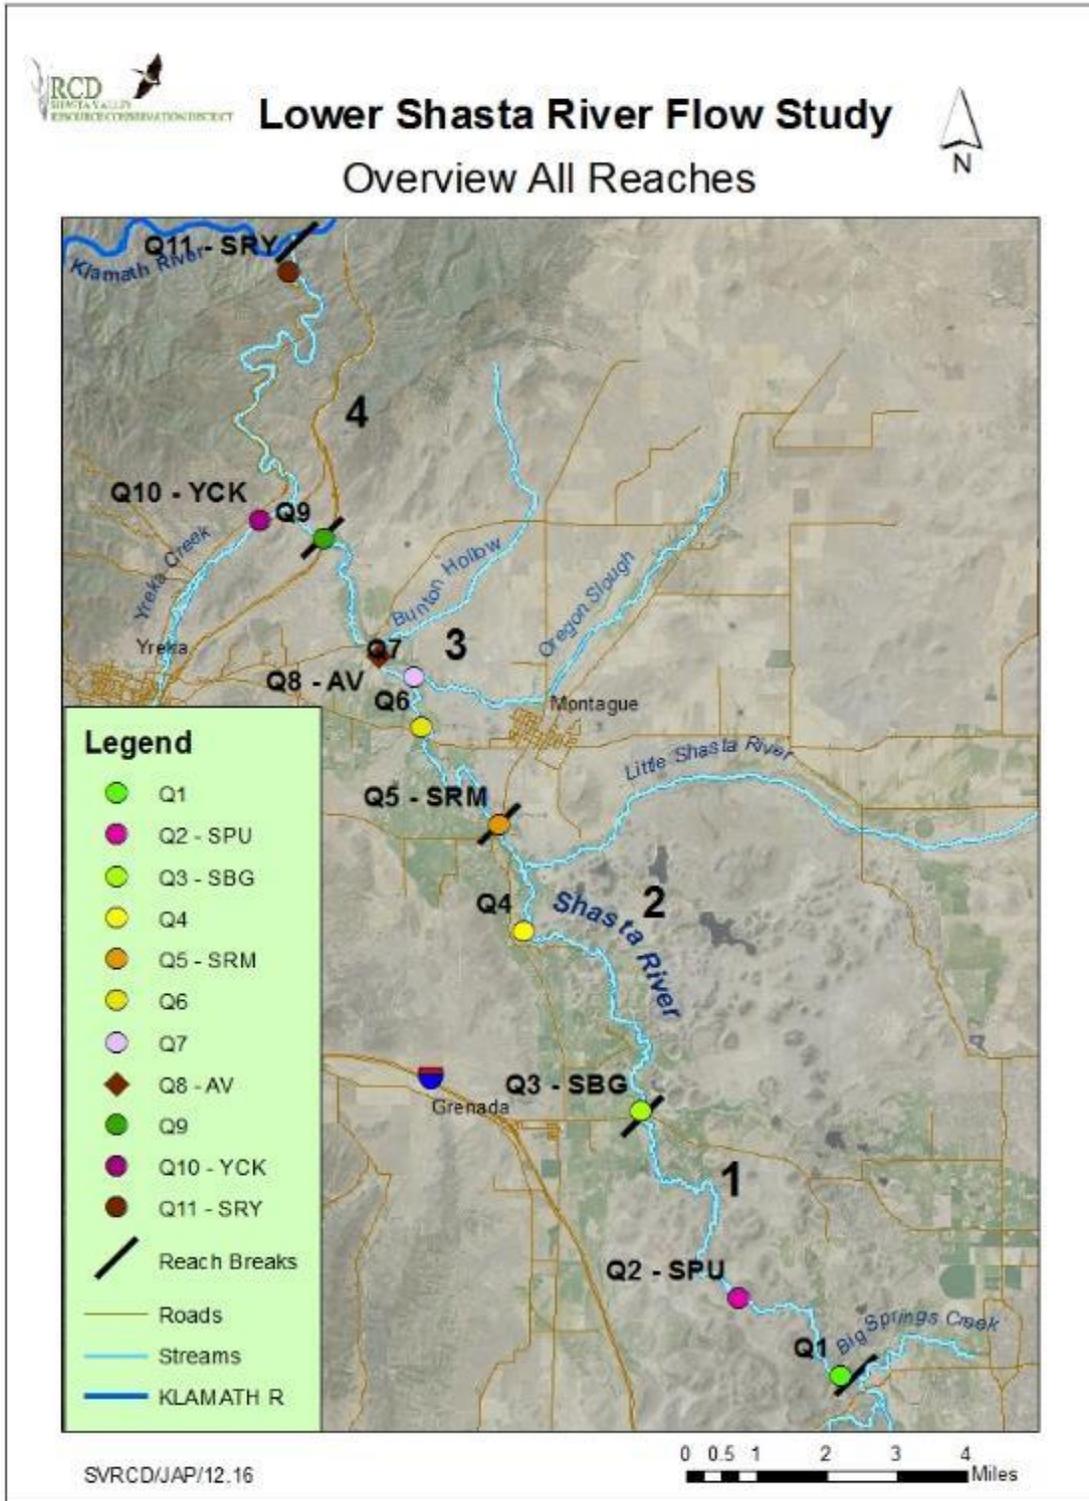
The study area spans roughly 33 river miles and includes approximately 21 diversions/diversion points with a diversion potential of up to 143 CFS. The study area was broken up into four reaches. The study area, reaches, and flow measurement stations are identified on Figure 4. Detailed maps of reaches 1 through 4 including diversion locations are provided in Section v. Study Area: Reach Descriptions. Flow measurement station locations were chosen so that: 1) they were spread throughout the study area; 2) they provided relatively easy access; and the cross-sectional area was ideal for a flow measurement.

FIGURE 4. MAP OF LOWER SHASTA RIVER AND MAJOR TRIBUTARIES WITH ALL MEASUREMENT SITES INCLUDING DISCHARGE TRANSECTS, INSTALLED AREA-VELOCITY METERS, AND EXISTING GAGES.

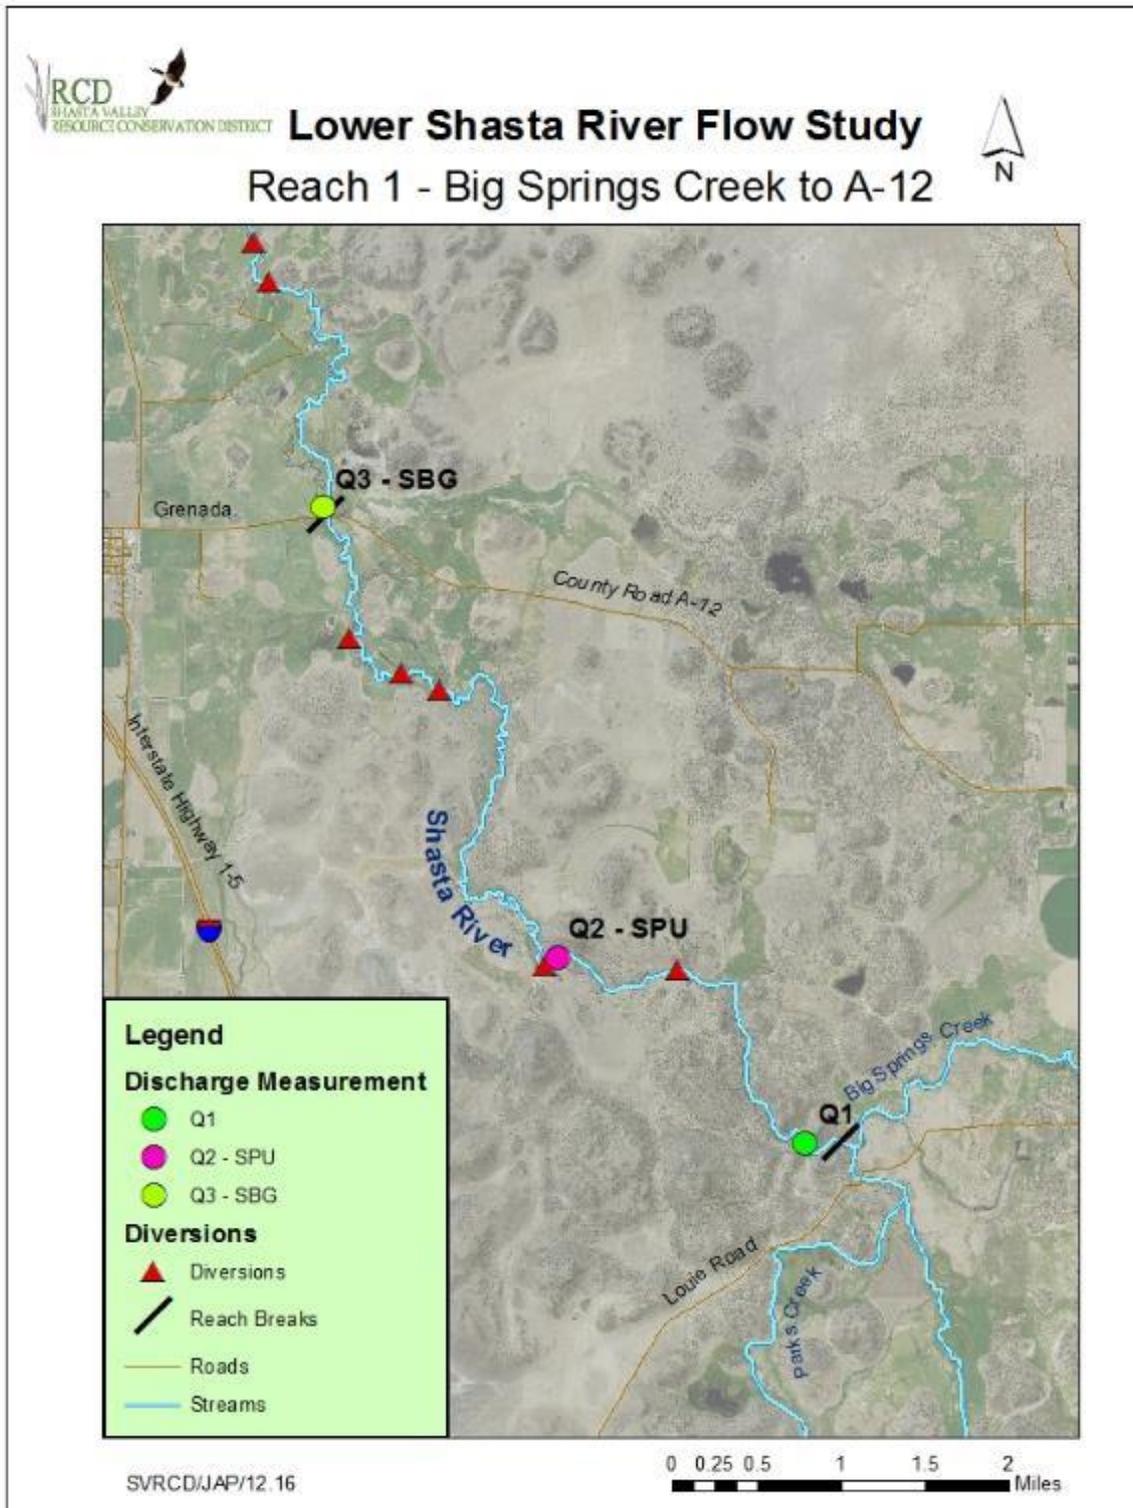
FIGURE 5. MAP OF REACH 1: BIG SPRINGS CREEK TO COUNTY RD. A-12, WITH FLOW MEASUREMENT SITES, REACH BREAKS, AND DIVERSIONS.

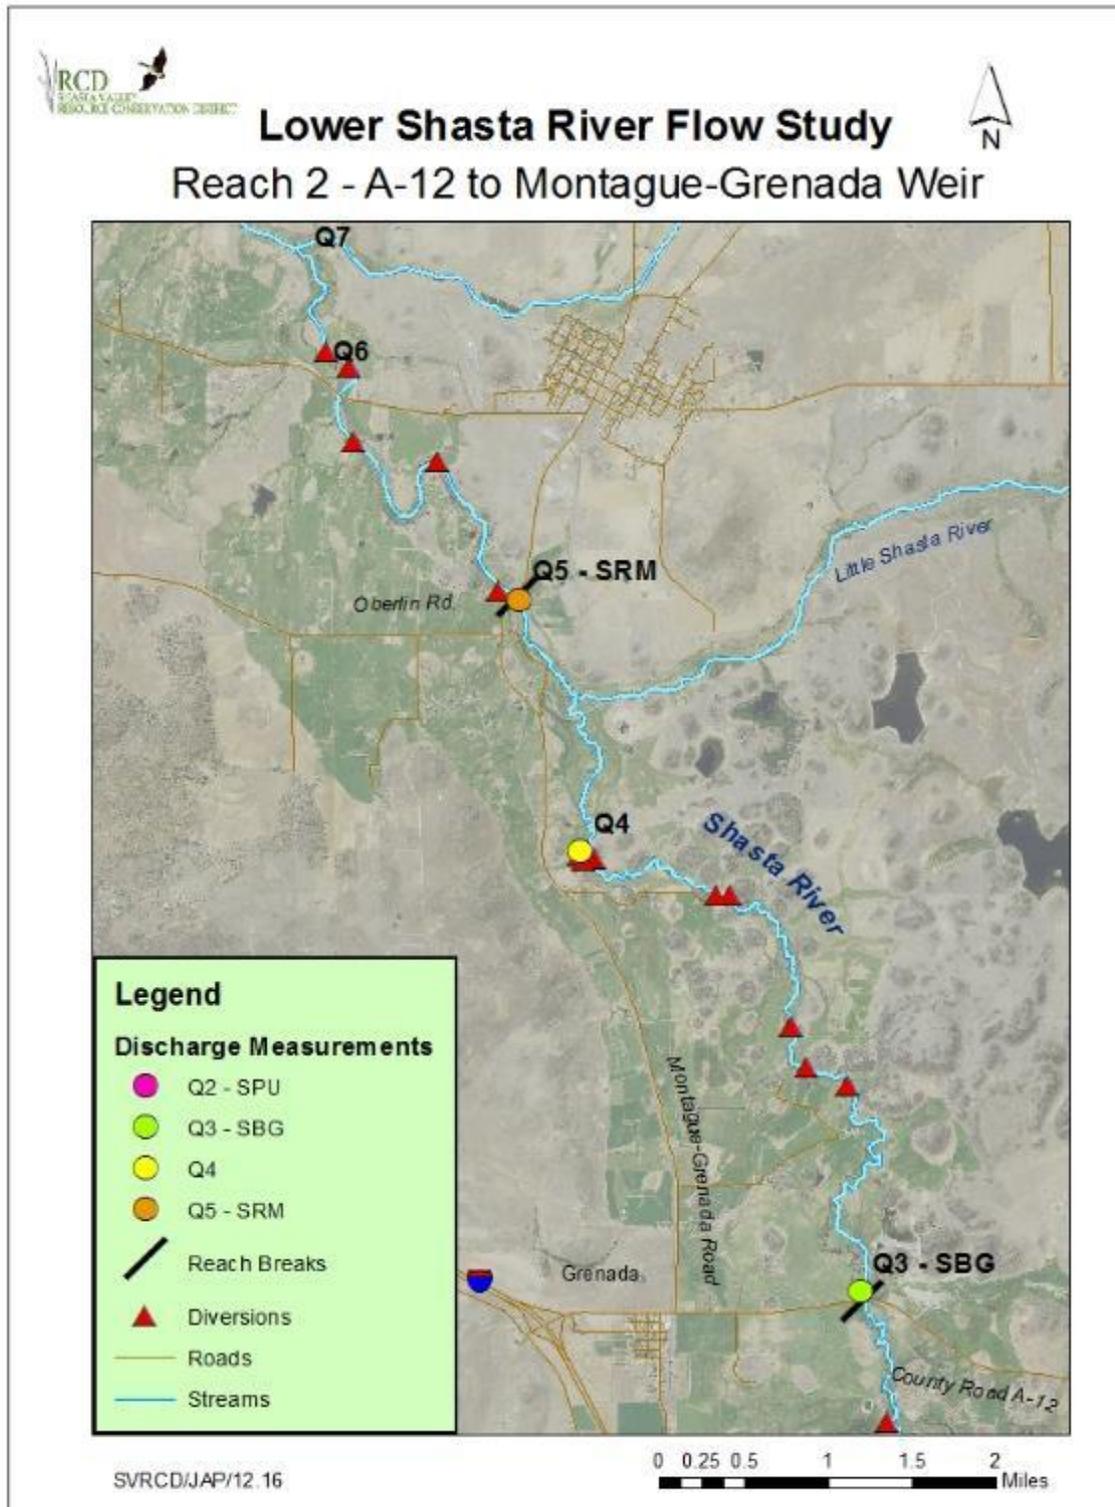
FIGURE 6. MAP OF REACH 2: COUNTY RD. A-12 TO MONTAGUE GRENADA RD. WEIR WITH FLOW MEASUREMENT SITES, REACH BREAKS, AND DIVERSIONS.

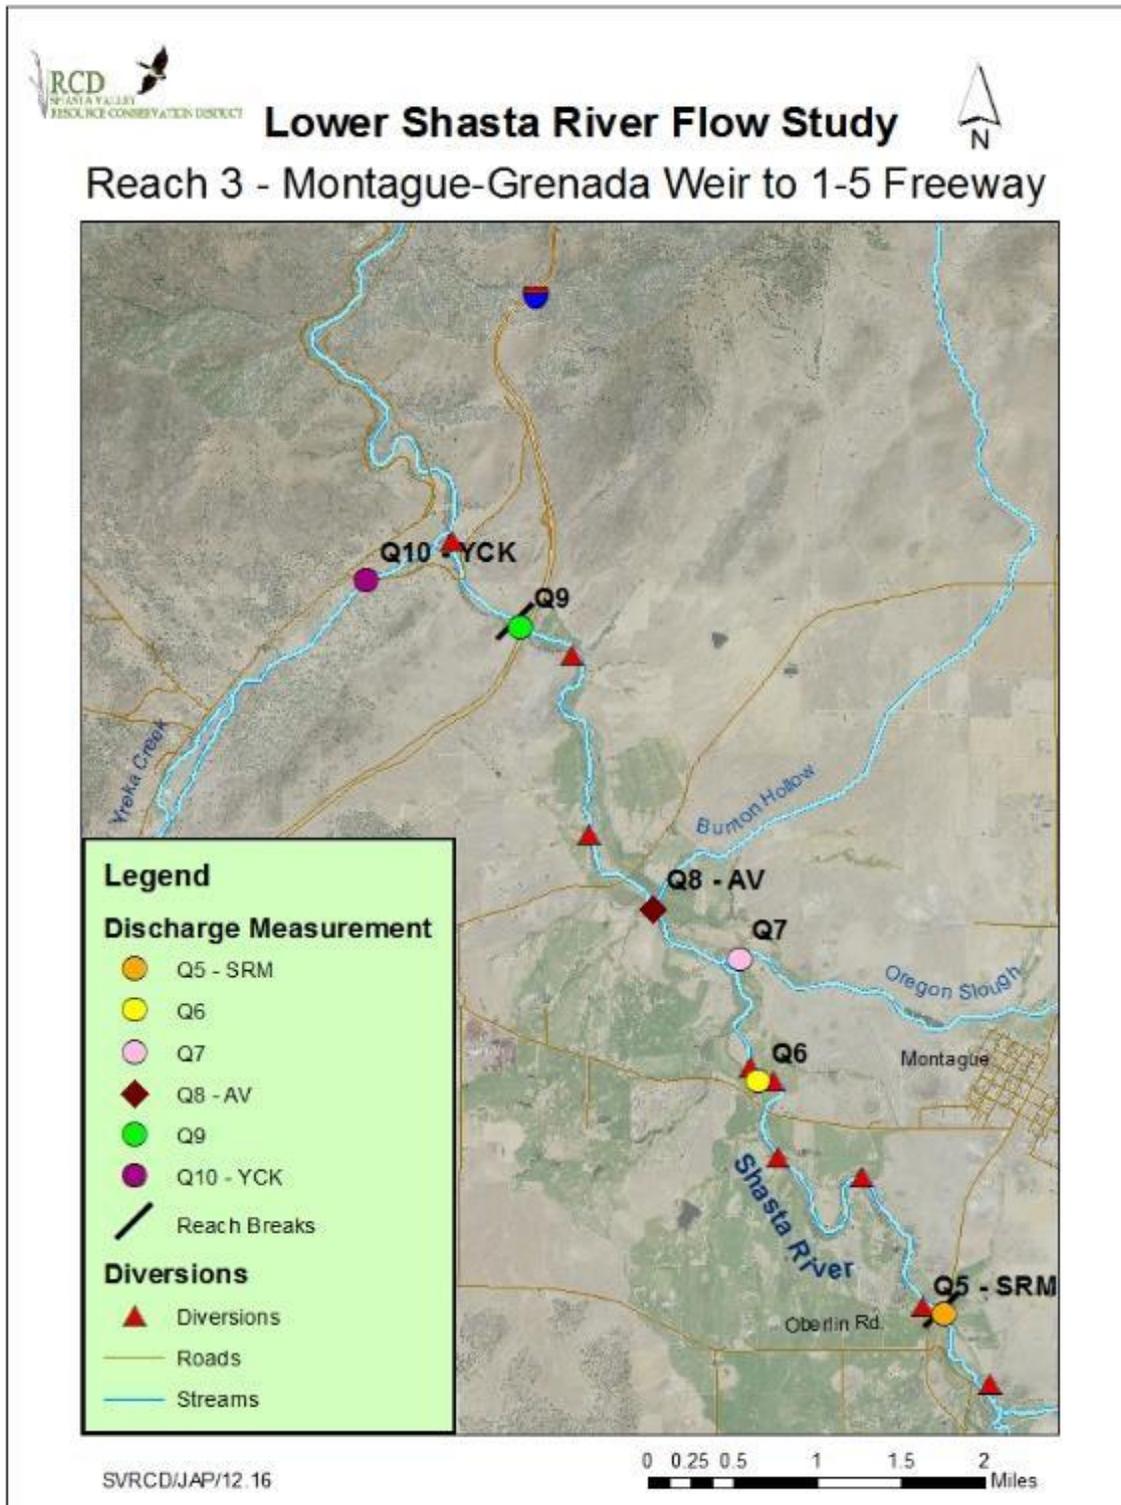
FIGURE 7. MAP OF REACH 3: MONTAGUE GRENADA RD. WEIR TO ABOVE I-5 FREEWAY CROSSING WITH FLOW MEASUREMENT SITES, REACH BREAKS, AND DIVERSIONS.

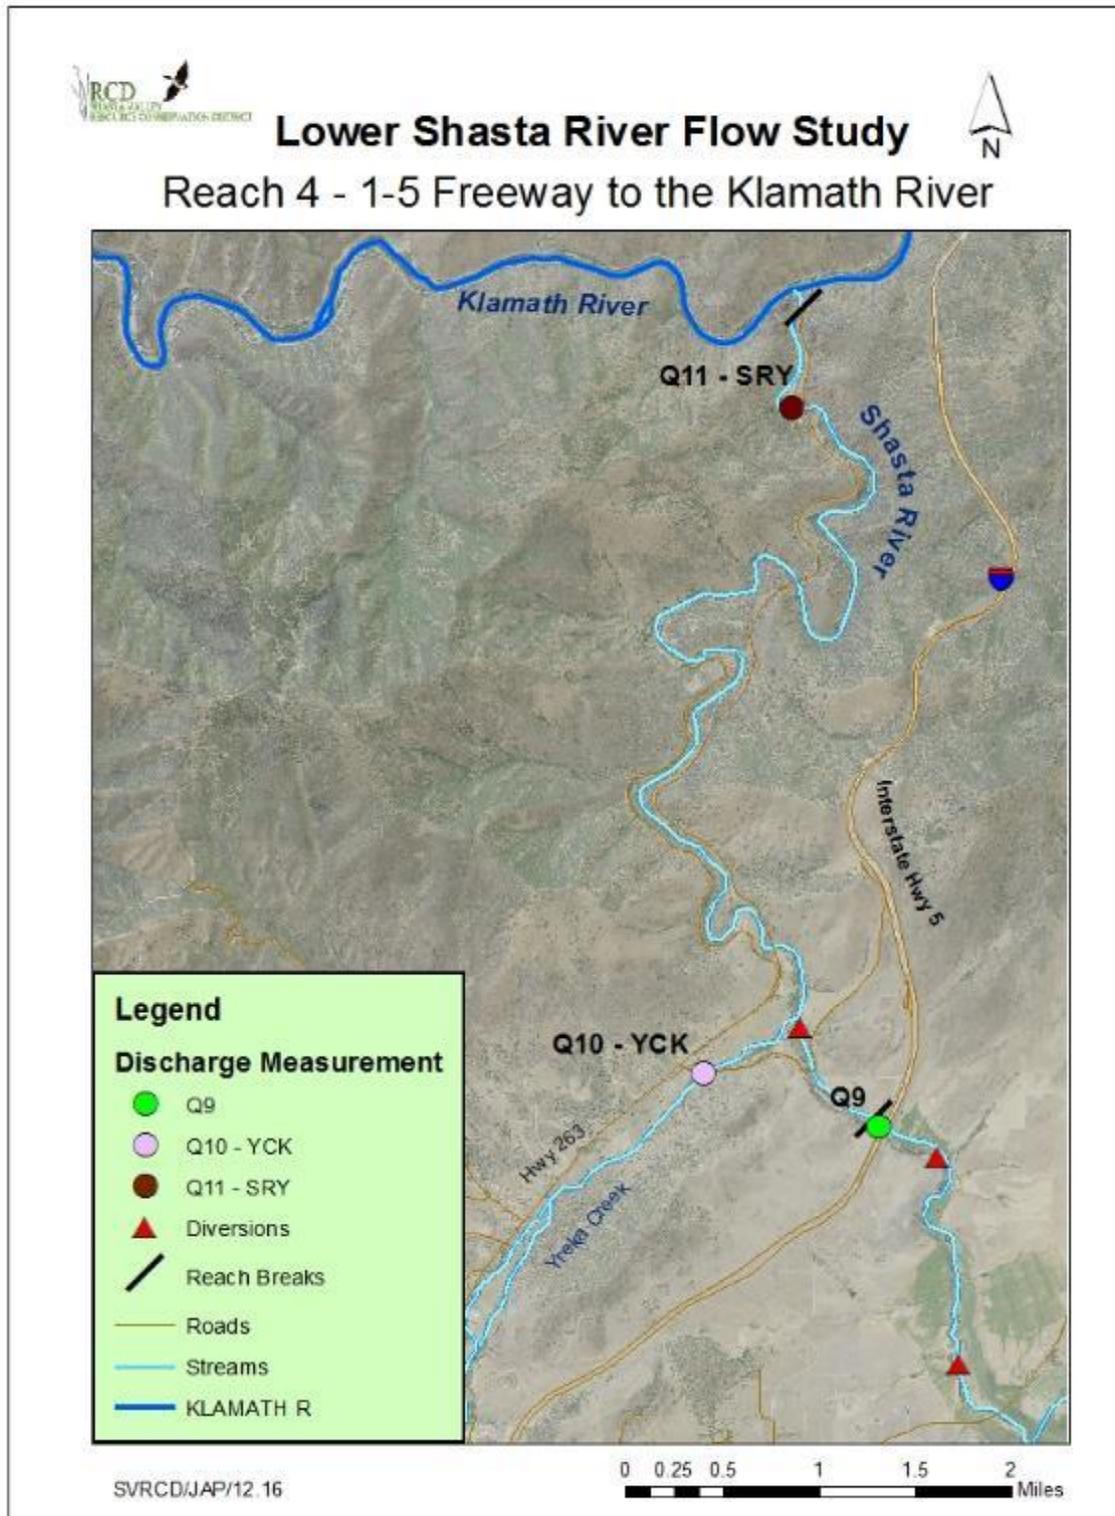
FIGURE 8. ABOVE INTERSTATE 5 FREEWAY CROSSING TO SHASTA RIVER CANYON AT RM 0.5 WITH FLOW MEASUREMENT SITES, REACH BREAKS, AND DIVERSIONS.

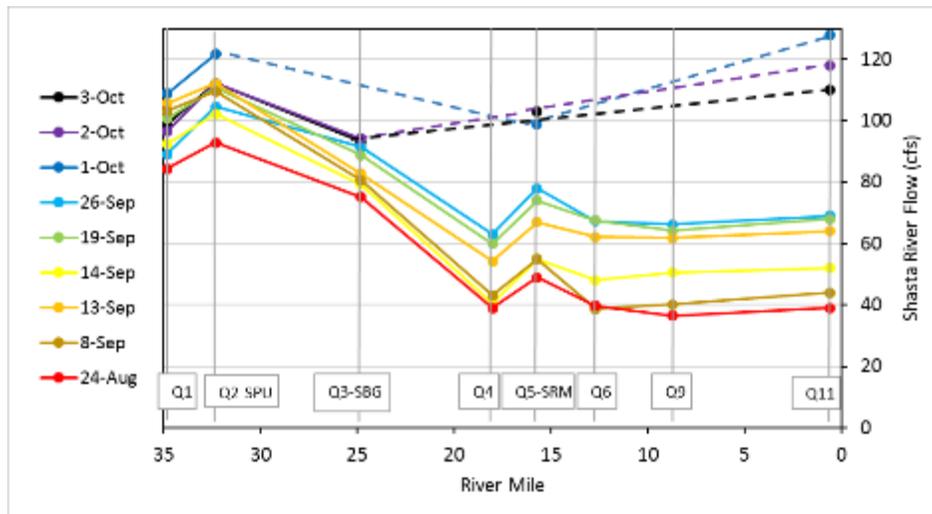
FIGURE 9. SHASTA RIVER FLOWS BY RIVER MILE ON DATE/TIMES ASSOCIATED WITH EACH MEASUREMENT DAY DURING THE STUDY PERIOD.

Irrigation return flow is known to occur in this subreach. Irrigation return flow is sporadic in nature and therefore, may not lead to the consistent accretion observed in this subreach. As described in on page 25 in reference to Figure 9, this consistent accretion may originate from Little Shasta River subsurface inflow.

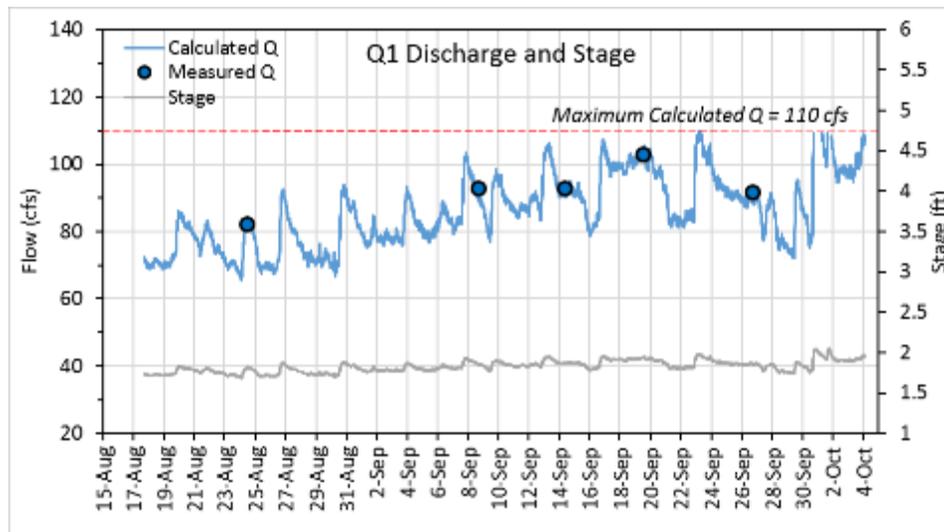
Q1 15-minute discharge hydrograph with measured discharge and associated stage values is displayed in Figure 10. Discharge measurements are lacking to define the upper end of the rating and therefore, flows greater than 110 cfs could not be calculated. Flow ranged from approximately 70 cfs to >110 cfs with large fluctuations in flow (approximately 5 to 20 cfs) over 1 to 4 day cycles, and a general trend of increasing flows over the study period.

FIGURE 10. STAGE, MEASURED FLOW (Q), AND CALCULATED FLOW (Q) FOR Q1 THROUGHOUT THE STUDY PERIOD: AUGUST 17TH THROUGH OCTOBER 4TH, 2016.

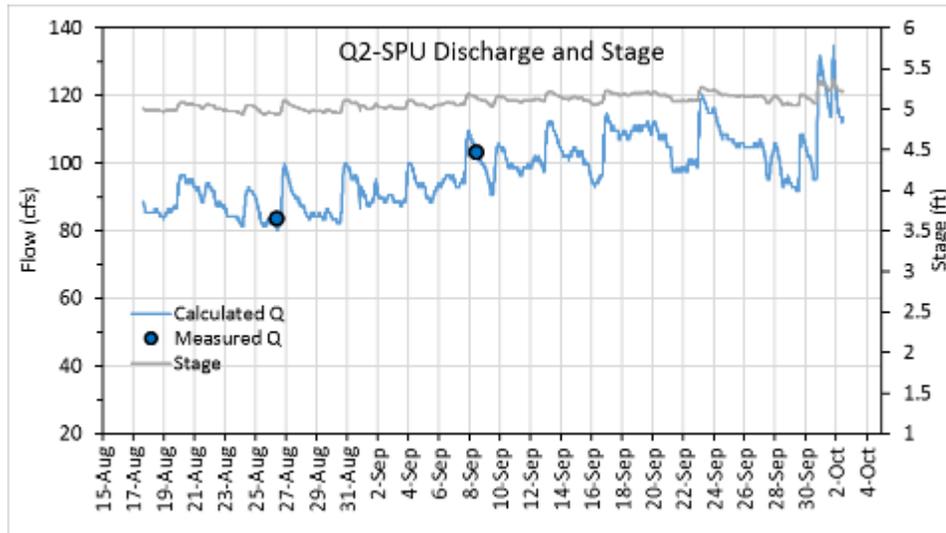
Q2-SPU 15-minute discharge hydrograph with measured discharge and associated stage values is displayed in Figure 11. Flow ranged from approximately 80 cfs to 135 cfs during the study period, with large fluctuations in flow (approximately 5 to 20 cfs) over 1 to 4 day cycles, and a general trend of increasing flows over the study period.

FIGURE 11. STAGE, MEASURED FLOW (Q), AND CALCULATED FLOW (Q) FOR Q2-SPU THROUGHOUT THE STUDY PERIOD: AUGUST 17TH THROUGH OCTOBER 3RD, 2016. FLOWS WERE LESS THAN THE MAXIMUM CALCULATED FLOW VALUE OF 140 CFS FOR THE ENTIRE STUDY PERIOD.

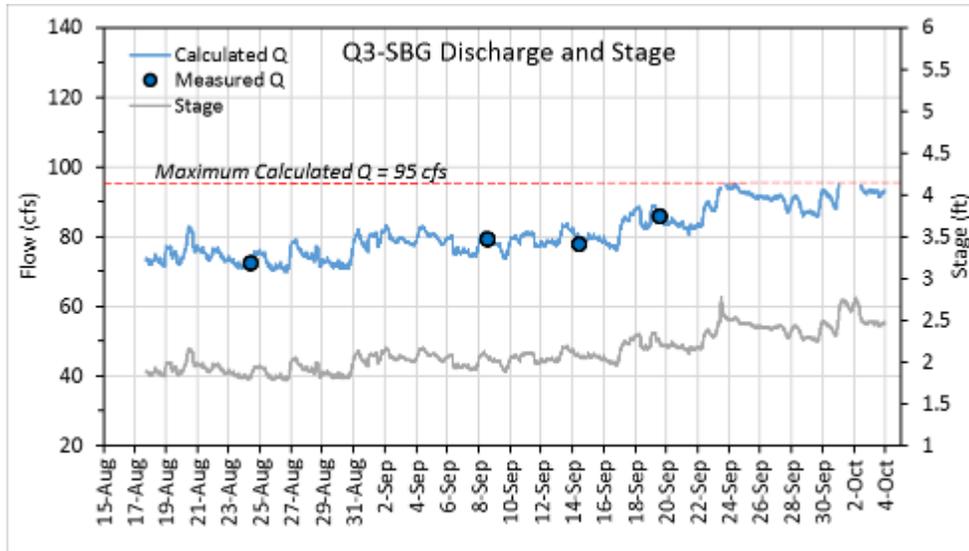
Q3-SBG 15-minute discharge hydrograph with measured discharge and associated stage values is displayed in Figure 12. Discharge measurements are lacking to define the upper end of the rating and therefore, flows greater than 95 cfs could not be calculated. Flow ranged from approximately 70 cfs to >95 cfs during the study period, with large fluctuations in flow (approximately 5 to 10 cfs) over 1 to 4 day cycles, and a general trend of increasing flows over the study period.

FIGURE 12. STAGE, MEASURED FLOW (Q), AND CALCULATED FLOW (Q) FOR Q3-SBG THROUGHOUT THE STUDY PERIOD: AUGUST 17TH THROUGH OCTOBER 4TH, 2016.

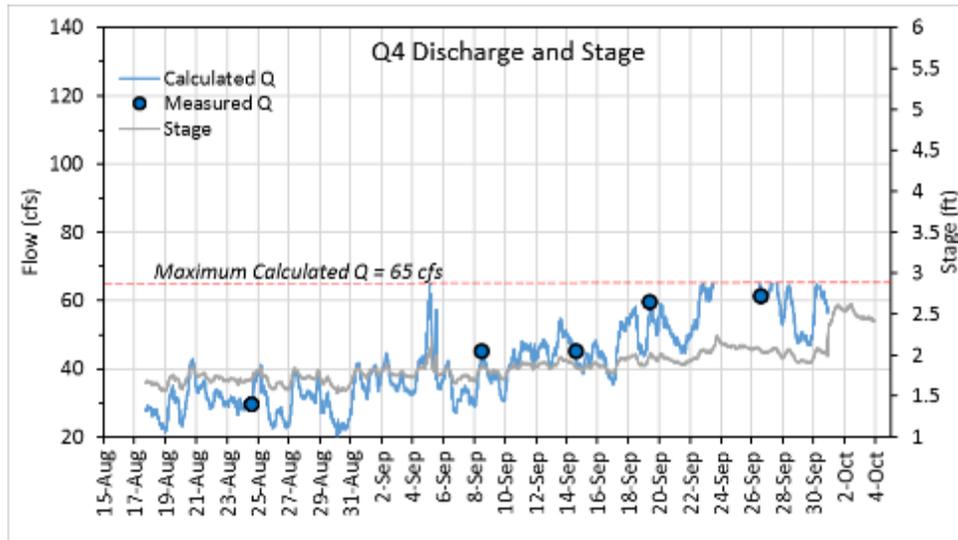
Q4 15-minute discharge hydrograph with measured discharge and associated stage values is displayed in Figure 13. Discharge measurements are lacking to define the upper end of the rating and therefore, flows greater than 65 cfs could not be calculated. Flow ranged from approximately 20 cfs to >65 cfs during the study period, with large fluctuations in flow (approximately 5 to 10 cfs, at times increasing to 20 cfs) over 1 to 4 day cycles, and a general trend of increasing flows over the study period.

FIGURE 13. STAGE, MEASURED FLOW (Q), AND CALCULATED FLOW (Q) FOR Q4 THROUGHOUT THE STUDY PERIOD: AUGUST 17TH THROUGH OCTOBER 4TH, 2016.

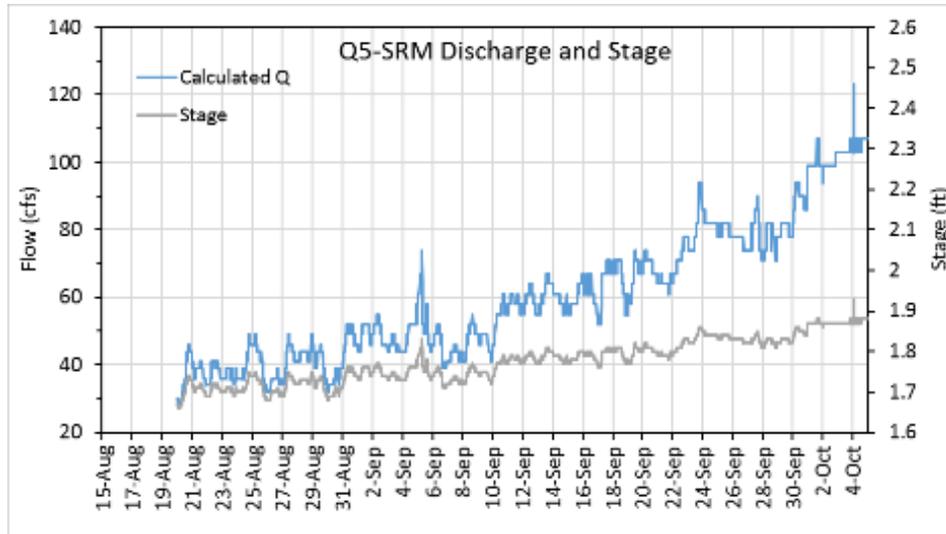
Q5-SRM 15-minute discharge hydrograph with associated stage values is displayed in Figure 14. Flow ranged from approximately 30 cfs to 125 cfs during the study period, with large fluctuations in flow (approximately 5 to 10 cfs, at times increasing to 20 cfs) over 1 to 4 day cycles, and a general trend of increasing flows over the study period.

FIGURE 14. STAGE AND CALCULATED FLOW (Q) FOR Q5 THROUGHOUT THE STUDY PERIOD AT USGS SITE 11517000: AUGUST 20TH THROUGH OCTOBER 4TH, 2016. PROVISIONAL USGS DATA ARE PROVIDED BY USGS WATER FOR THE NATION, ACCESSED DECEMBER 2016.

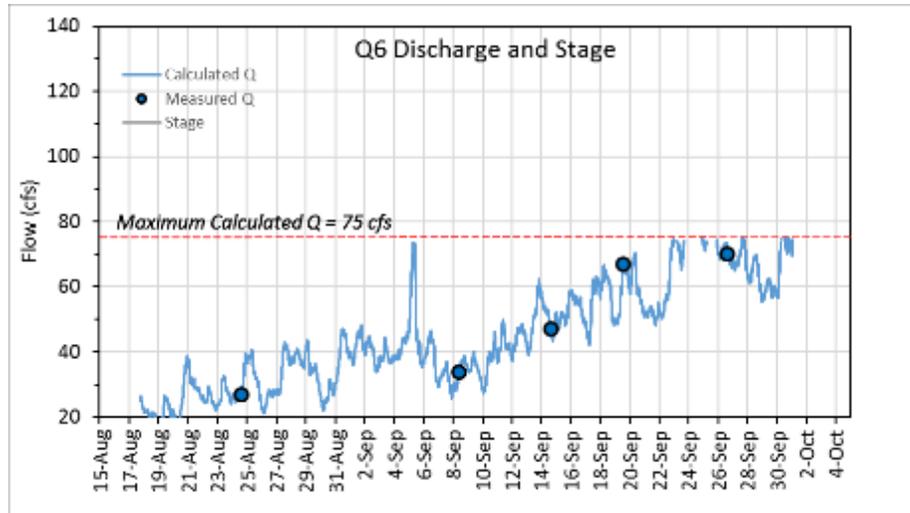
Q6 15-minute discharge hydrograph with measured discharge and associated stage values is displayed in Figure 15. Discharge measurements are lacking to define the upper end of the rating and therefore, flows greater than 75 cfs could not be calculated. Flow ranged from approximately 20 cfs to > 75 cfs during the study period, with large fluctuations in flow (approximately 10 to 20 cfs) over 1 to 4 day cycles, and a general trend of increasing flows over the study period.

FIGURE 15. STAGE, MEASURED FLOW (Q), AND CALCULATED FLOW (Q) FOR Q6 THROUGHOUT THE STUDY PERIOD: AUGUST 17TH THROUGH OCTOBER 4TH, 2016.

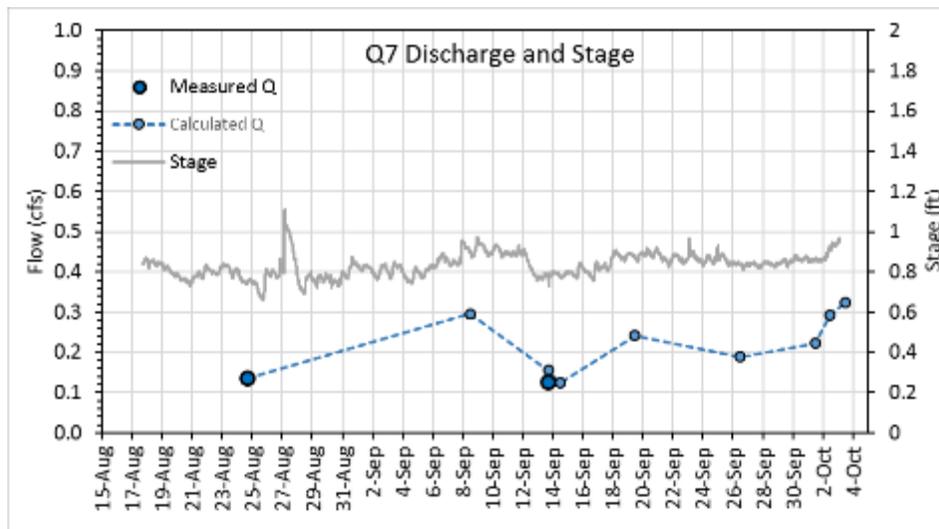
Q7 15-minute stage values are displayed in Figure 13. A rating curve was not created for this small inflow at Oregon Slough because only two discharge measurements were performed. Flow was calculated for assessment days using channel geometry and velocity spot checks. Flow was intermittent and minor (less than 0.2 CFS both times spot flow measurements were taken) throughout the study period.

FIGURE 16. STAGE AND MEASURED FLOW (Q) FOR Q7 THROUGHOUT THE STUDY PERIOD: AUGUST 17TH THROUGH OCTOBER 4TH, 2016. A RATING WAS NOT DEVELOPED AT Q7 BECAUSE ONLY TWO MEASUREMENTS WERE PERFORMED. INSTEAD, THE CONFINED CHANNEL GEOMETRY AND VELOCITY MEASUREMENTS WERE USED TO CALCULATE FLOWS ON ASSESSMENT DAYS.

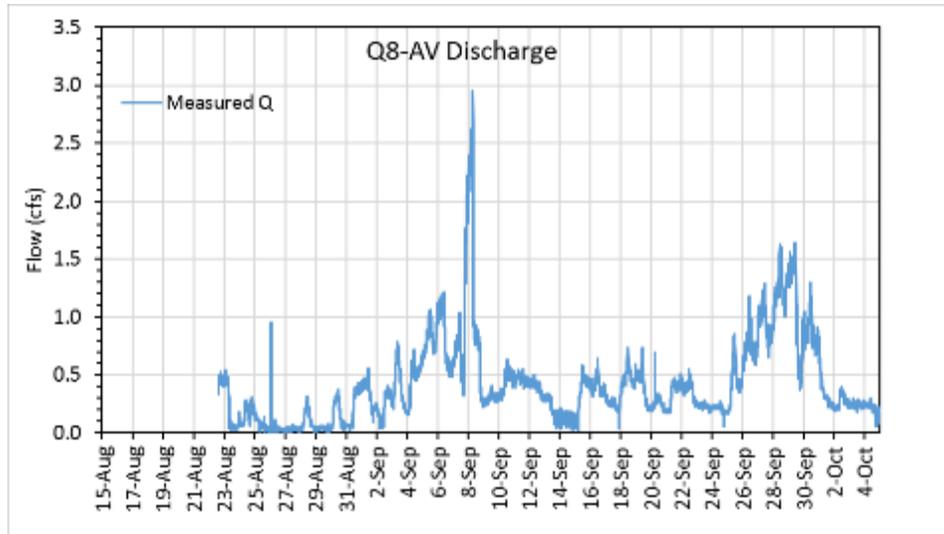
Q8-AV 15-minute discharge hydrograph is displayed in Figure 17 created with continuous (15-minute) flow data collected by A-V meters installed in 2 culverts. Flow ranged from 0 to 3 cfs during the study period. Flows in this intermittent stream channel during the study period most likely originated from irrigation return flows.

FIGURE 17. CALCULATED FLOW (Q) FOR Q8-AV METERS (TWO CULVERTS COMBINED) THROUGHOUT THE STUDY PERIOD: AUGUST 17TH THROUGH OCTOBER 4TH, 2016.

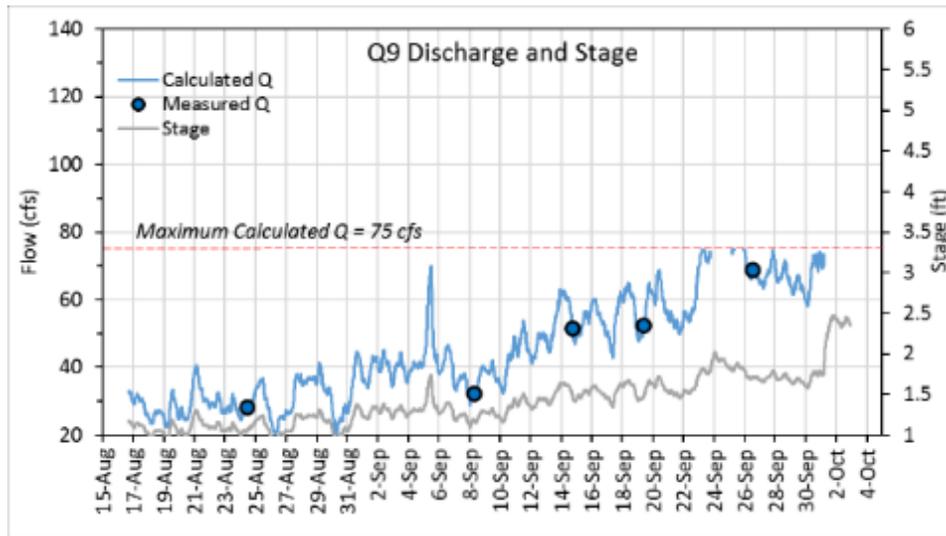
Q9 15-minute discharge hydrograph with measured discharge and associated stage values is displayed in Figure 18. Discharge measurements are lacking to define the upper end of the rating and therefore, flows greater than 75 cfs could not be calculated. Flow ranged from approximately 20 cfs to > 75 cfs during the study period, with large fluctuations in flow (approximately 5 to 20 cfs) over 1 to 4 day cycles, and a general trend of increasing flows over the study period.

FIGURE 18. STAGE, MEASURED FLOW (Q), AND CALCULATED FLOW (Q) FOR Q9 THROUGHOUT THE STUDY PERIOD: AUGUST 17TH THROUGH OCTOBER 3RD, 2016.

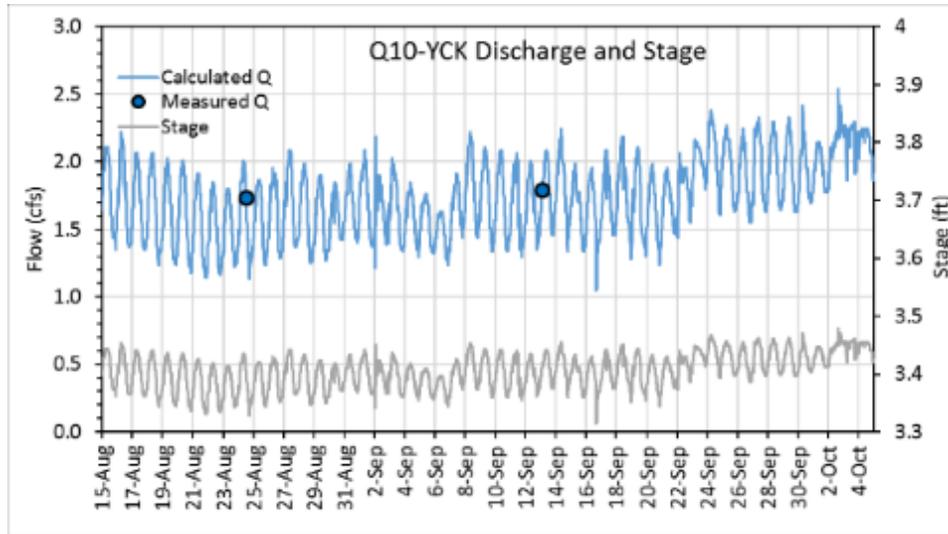
Q10-YCK 15-minute discharge hydrograph with measured discharge and associated stage values is displayed in Figure 19. Flow ranged from approximately 1.1 cfs to 2.5 cfs during the study period, with small (approximately 0.7 cfs) diurnal fluctuations throughout and a slight increase in flow over the study period.

FIGURE 19. STAGE, MEASURED FLOW (Q), AND CALCULATED FLOW (Q) FOR Q10-YCK THROUGHOUT THE STUDY PERIOD: AUGUST 17TH THROUGH OCTOBER 3RD, 2016. FLOWS WERE LESS THAN THE MAXIMUM CALCULATED FLOW VALUE OF 70 CFS FOR THE RATING CURVE FOR THE ENTIRE STUDY PERIOD.

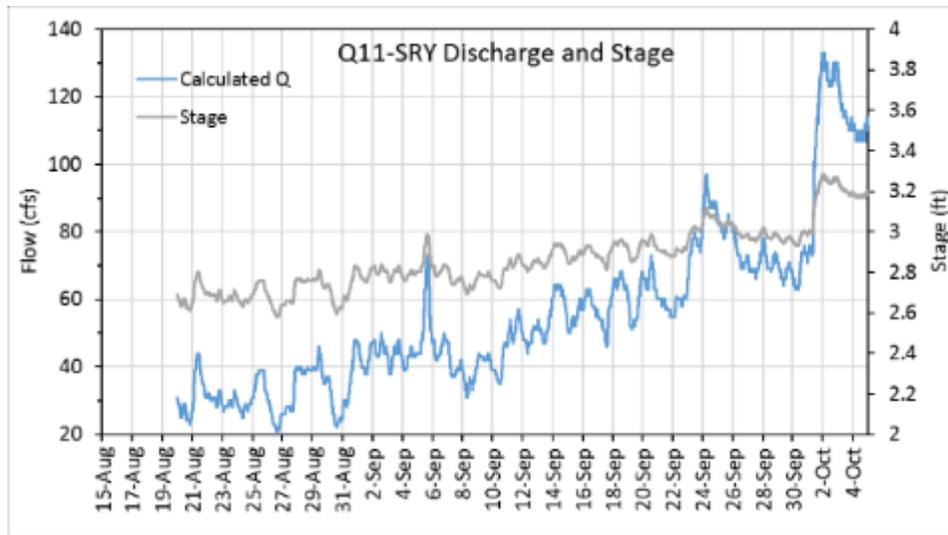
Q11-SRY 15-minute discharge hydrograph with associated stage values is displayed in Figure 20. Flow ranged from approximately 20 cfs to 130 cfs during the study period, with large fluctuations in flow (approximately 5 to 15 cfs) over 1 to 4 day cycles, and a general trend of increasing flows over the study period.

FIGURE 20. STAGE AND CALCULATED FLOW (Q) FOR Q11-SRY THROUGHOUT THE STUDY PERIOD AT USGS SITE 11517500: AUGUST 20TH THROUGH OCTOBER 4TH, 2016. PROVISIONAL USGS DATA ARE PROVIDED BY USGS WATER FOR THE NATION, ACCESSED DECEMBER 2016.

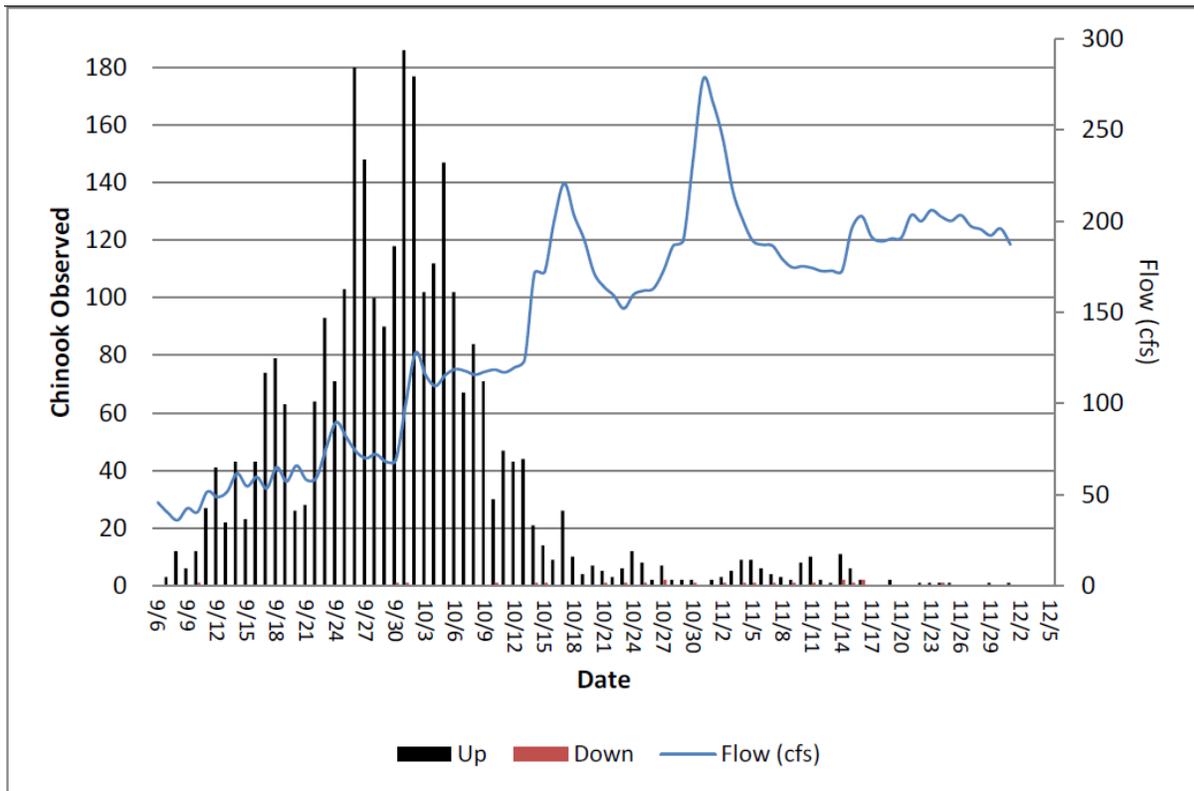
FIGURE 2. CHINOOK SALMON OBSERVED MIGRATING THROUGH SHASTA RIVER FISH COUNTING FACILITY IN 2016, AND FLOW FROM NEARBY USGS GAUGE (GRAPHIC RETRIEVED FROM CHESNEY & KNECHTLE, 2017).

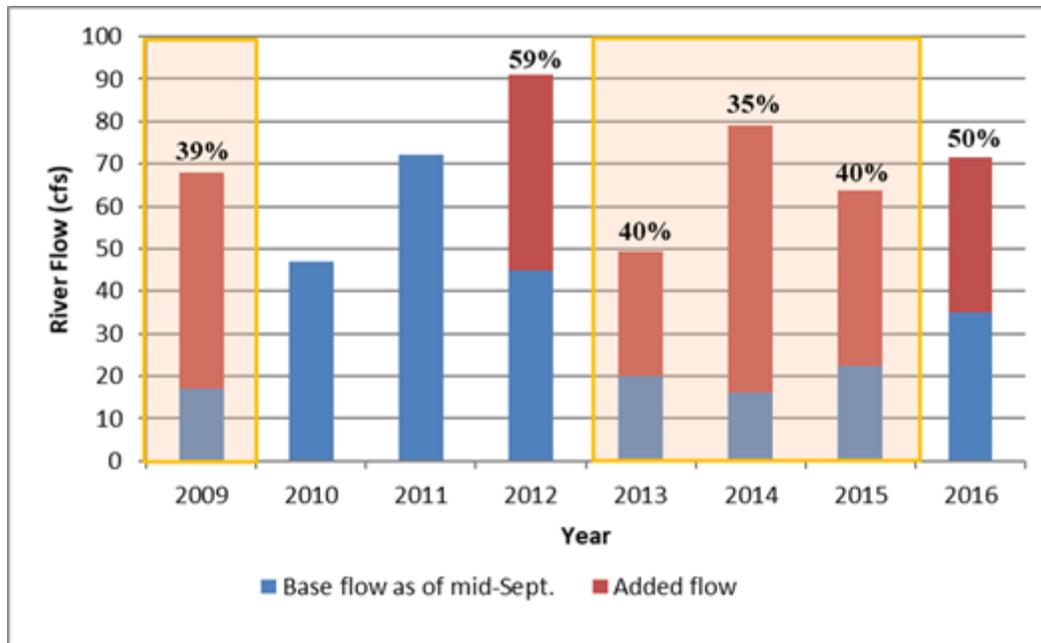
FIGURE 3. BASE FLOW AND FLOW CONTRIBUTIONS (ADDED FLOW) SECURED BY TNC'S FALL FLOW PROGRAM (GRAPHIC COURTESY OF ADA FOWLER, TNC).

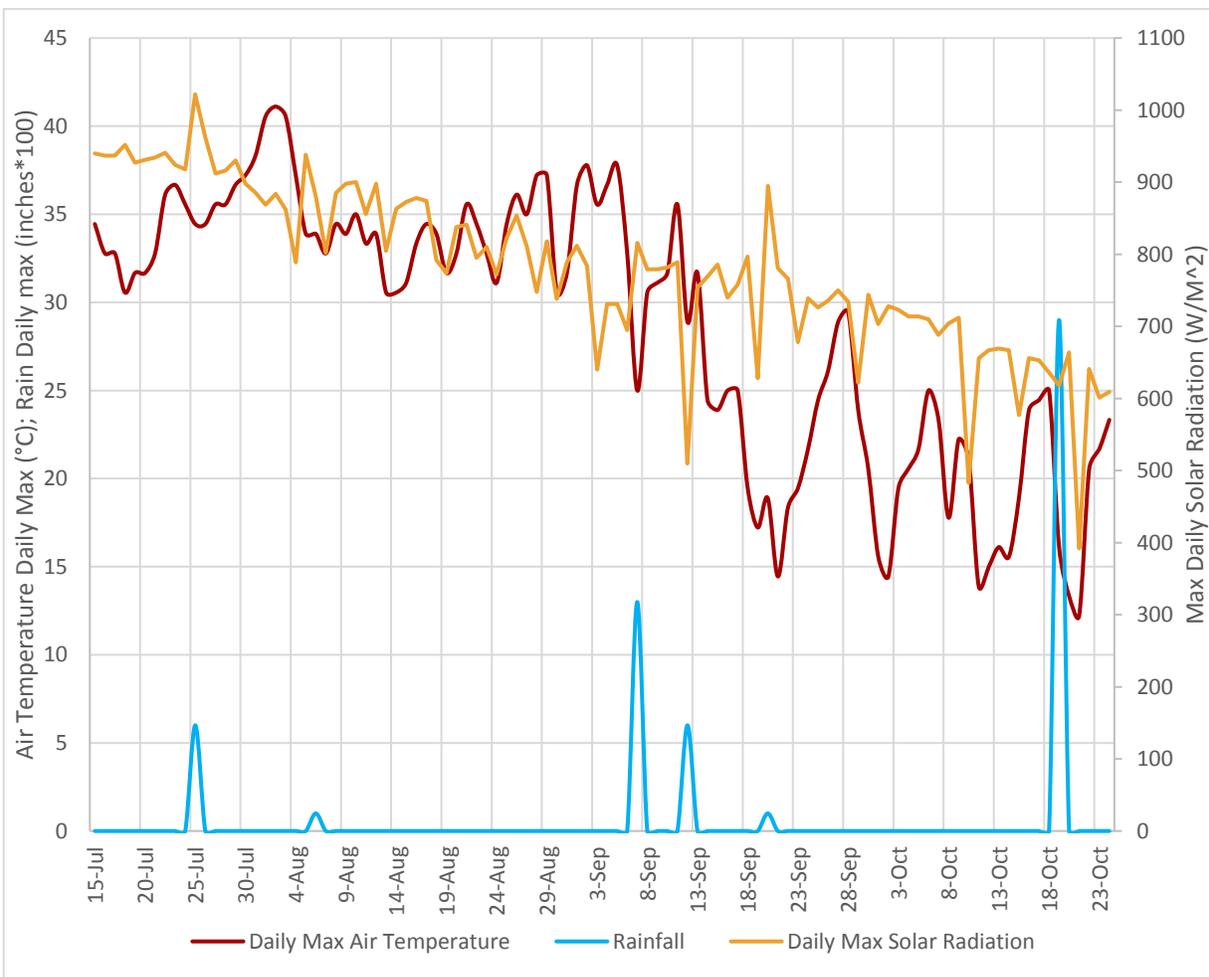
FIGURE 4. METEOROLOGICAL DATA INCLUDING MAXIMUM AIR TEMPERATURE, SOLAR RADIATION, AND PRECIPITATION DURING LATE SUMMER AND FALL 2017 WITH STUDY PERIOD HIGHLIGHTED. DATA SOURCE CDEC STATION WED (WEED AIRPORT): JULY 15, 2017 - OCT. 24, 2017.
