Appendix 3-D. Interconnected Surface Water Sustainability Management Criteria

13 **LOWER SHASTA RIVER WATER BALANCE: SEPTEMBER 2016**

LOWER SHASTA RIVER WATER BALANCE: SEPTEMBER 2016

MIDDLE SHASTA RIVER WATER BALANCE: SEPTEMBER-OCTOBER 2017

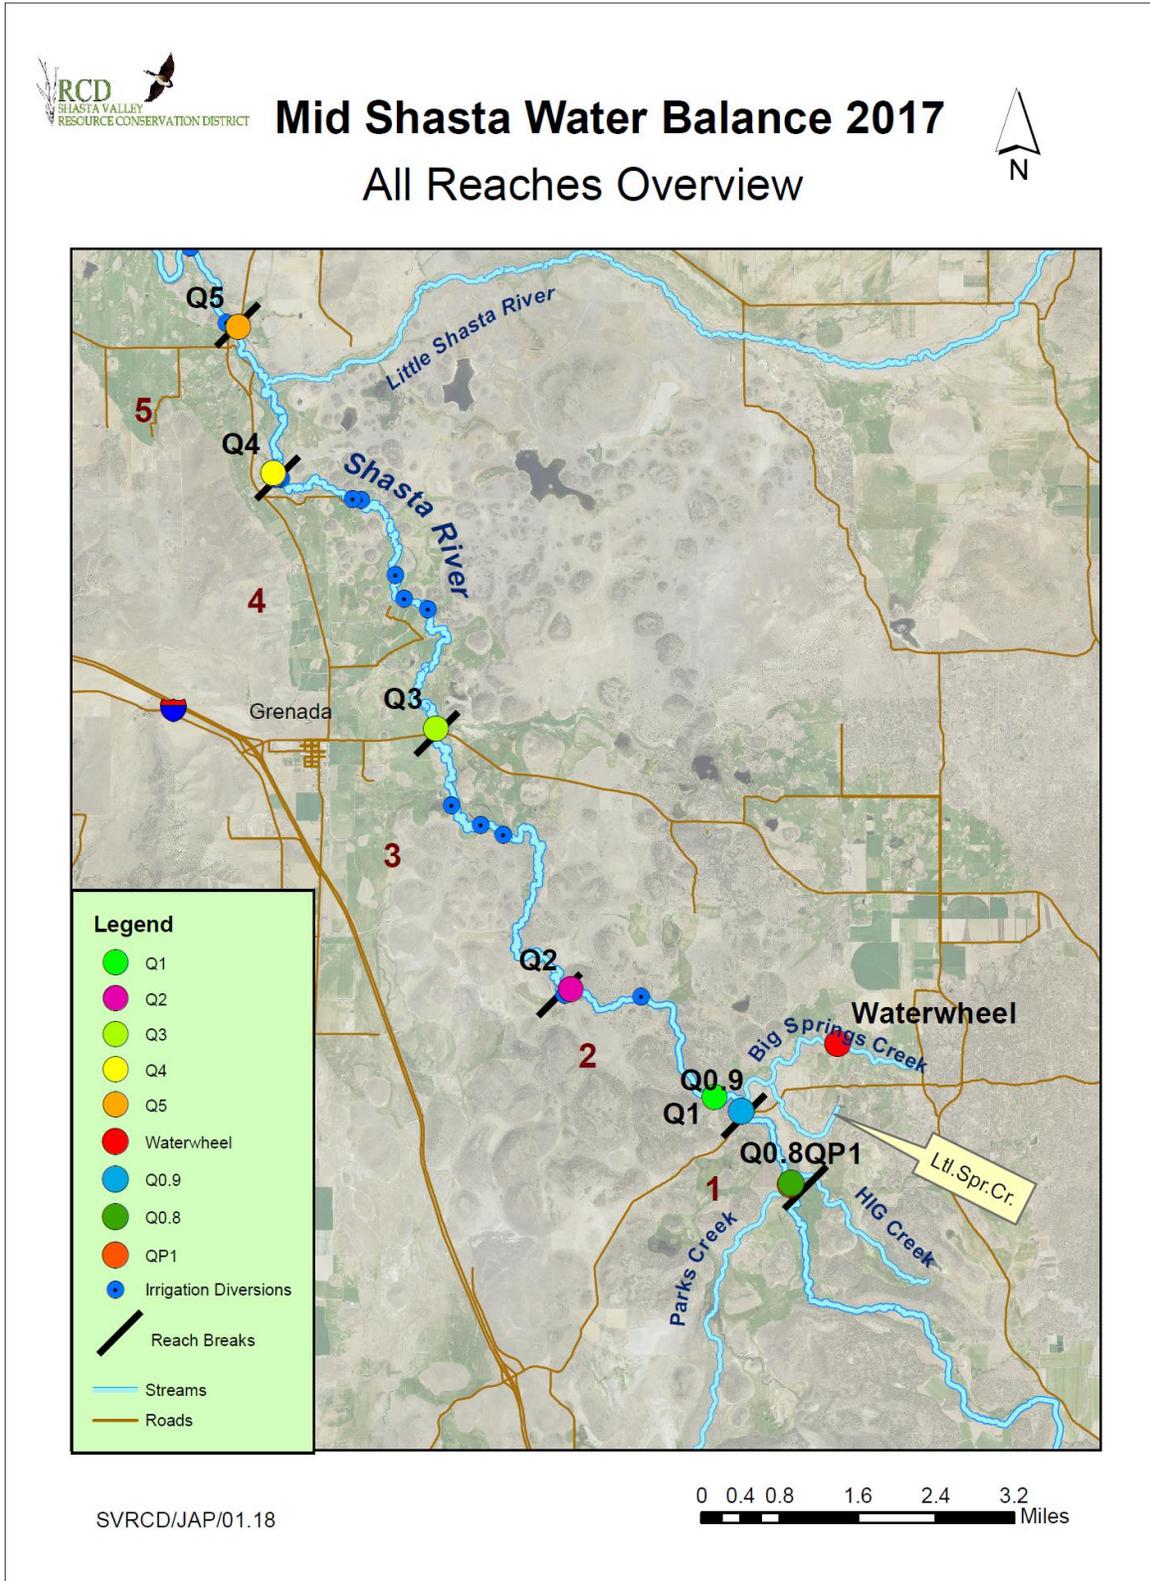
FIGURE 5. MAP OF FLOW STUDY AREA INCLUDING MAJOR TRIBUTARIES WITH ALL MEASUREMENT SITES (NUMBERS PRECEDED BY Q), EXISTING GAGES, AND REACHES (NUMBERS NOT PRECEDED BY Q).

Reach 3 has seven diversion points, with a diversion potential of up to 53 cfs. However, one large diversion (42 cfs) was turned off during the study period. Reach 3 can be found in Figure 5 .

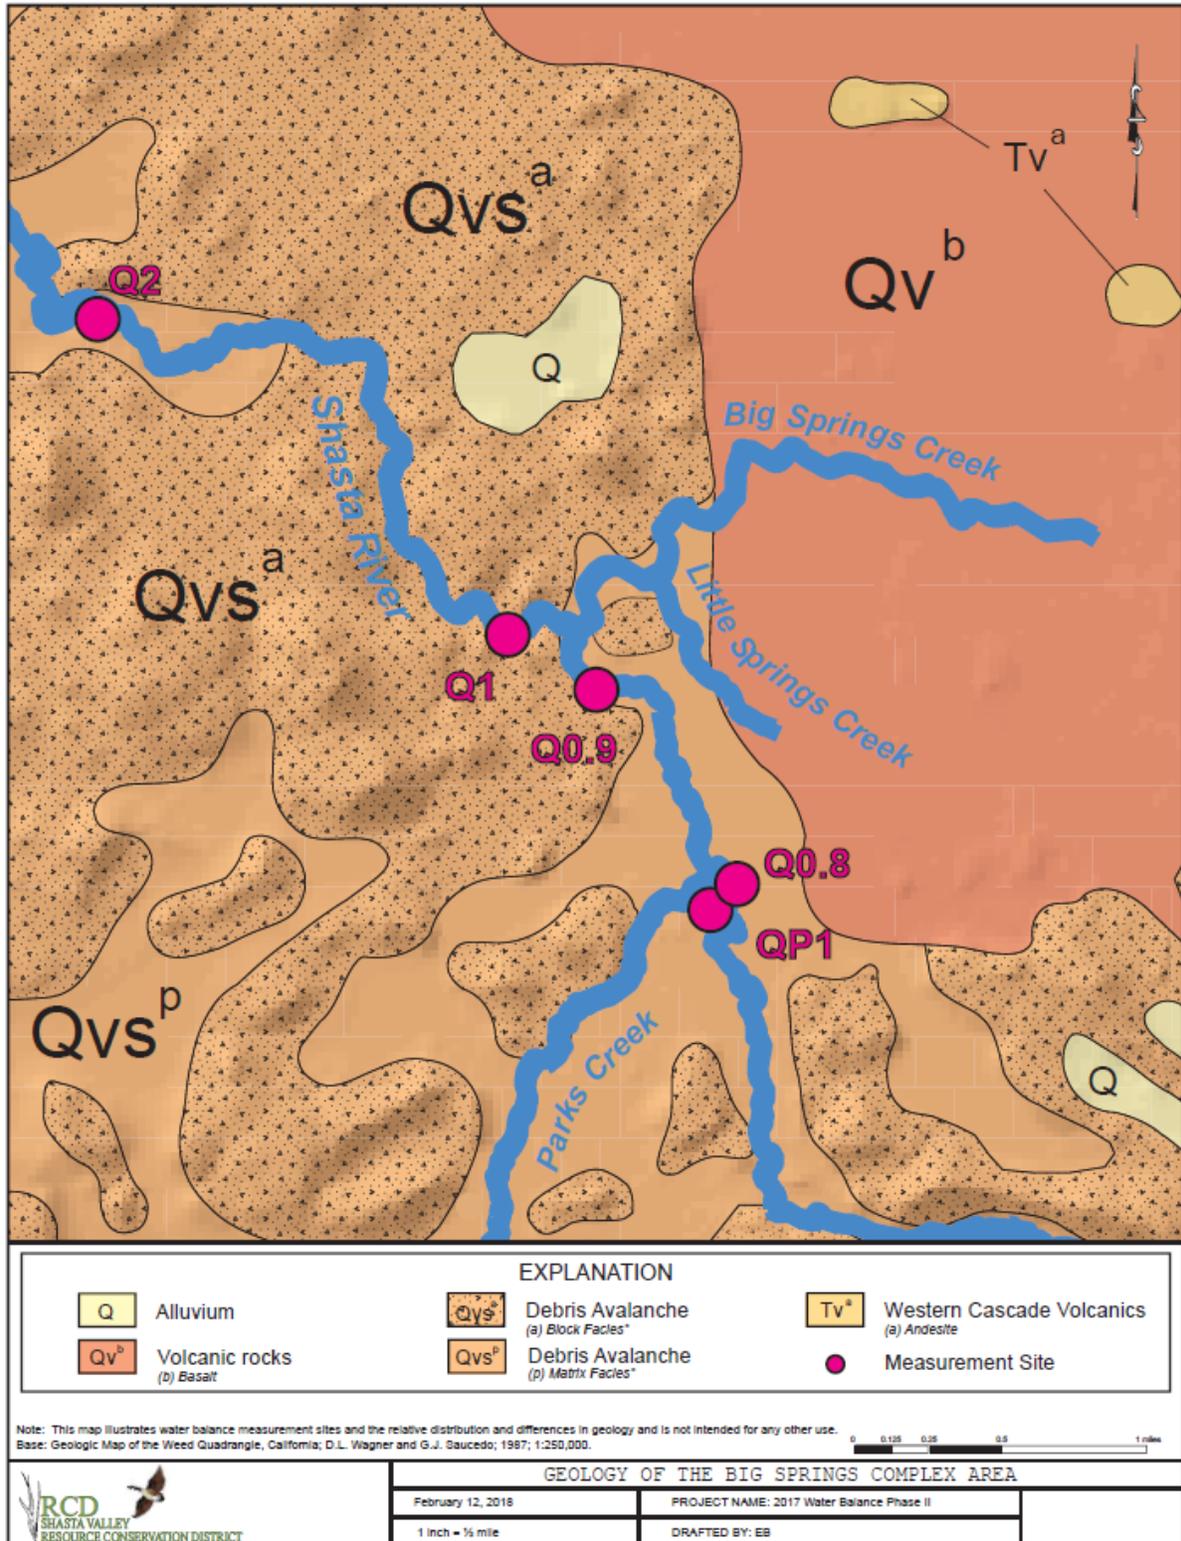
FIGURE 6. GEOLOGIC MAP OF THE BIG SPRINGS COMPLEX AREA.

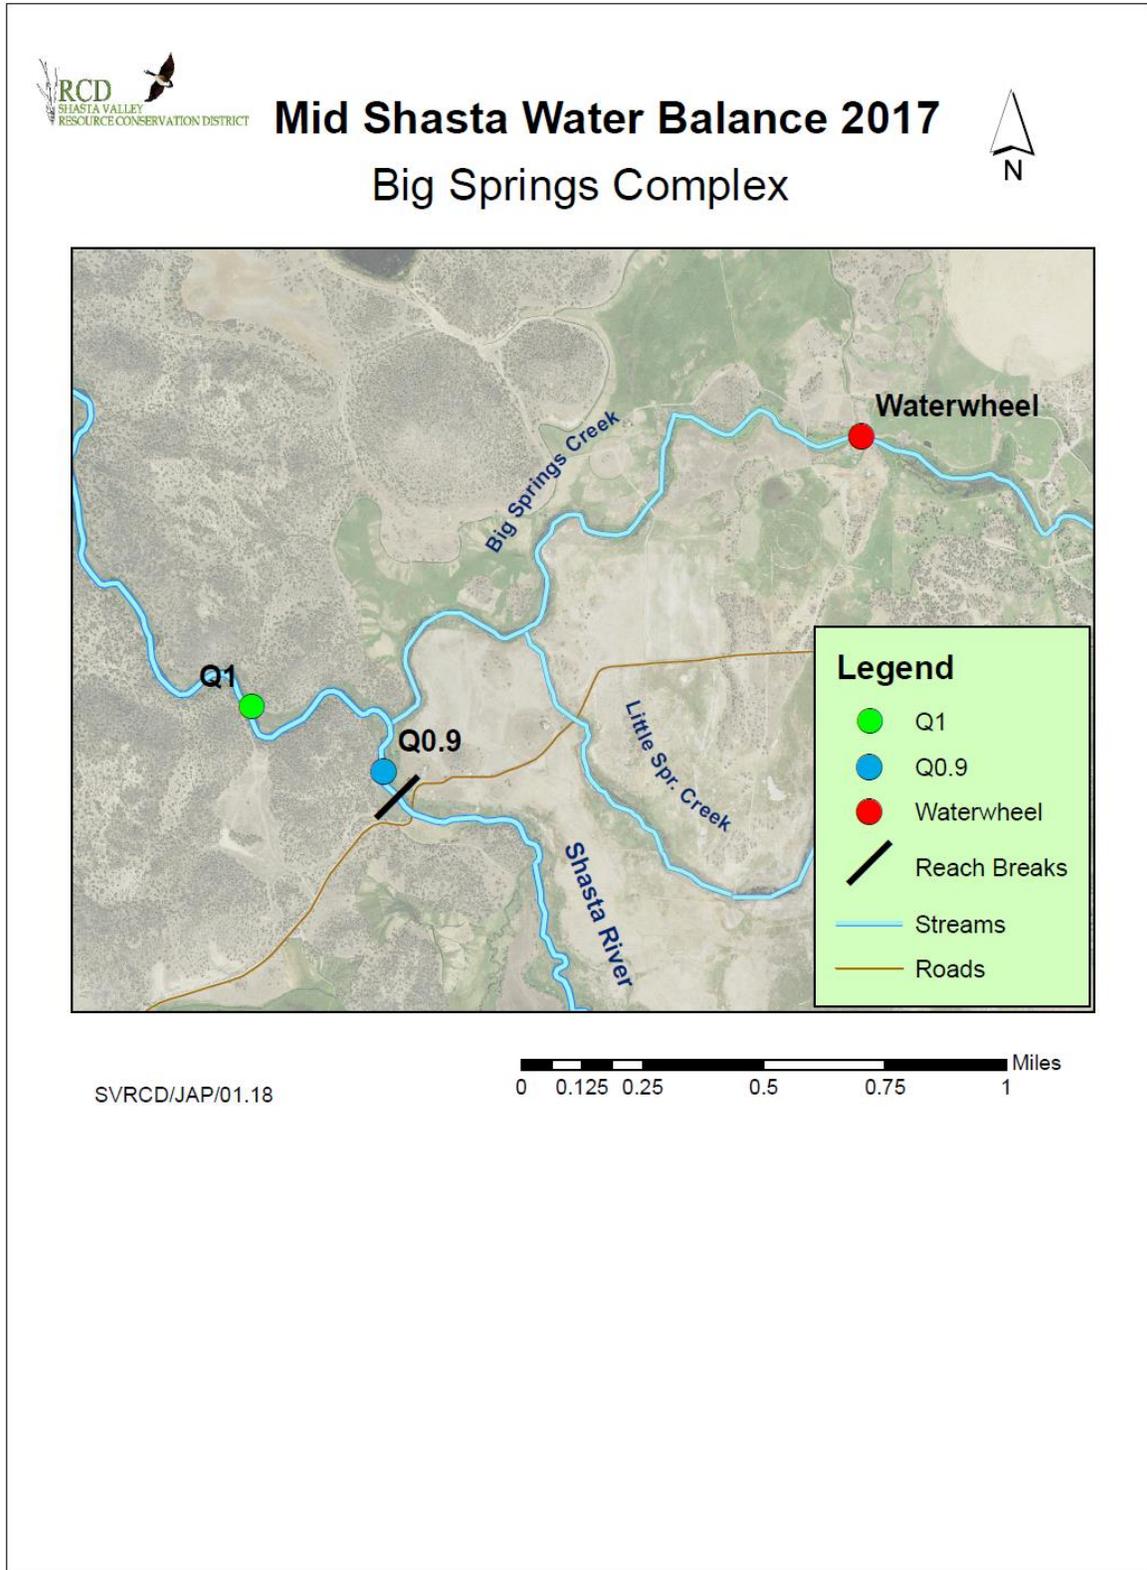
FIGURE 7. MAP OF THE BIG SPRINGS COMPLEX INCLUDING MEASUREMENT SITES AND “WATER WHEEL” EXISTING STAGE/DISCHARGE SITE ON BIG SPRINGS CREEK. ALSO IDENTIFIED IS LITTLE SPRINGS CREEK DOWNSTREAM OF THE WATER WHEEL SITE.

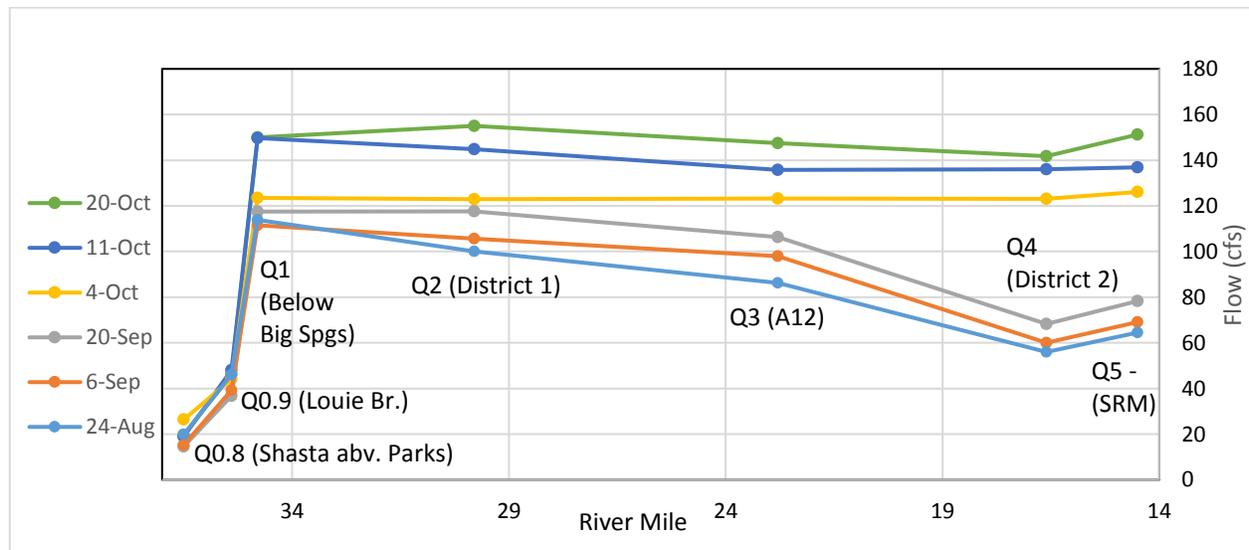
FIGURE 8. SHASTA RIVER CALCULATED FLOWS BY RIVER MILE ON DATE/TIMES ASSOCIATED WITH EACH ASSESSMENT DAY DURING THE STUDY PERIOD, 2017.

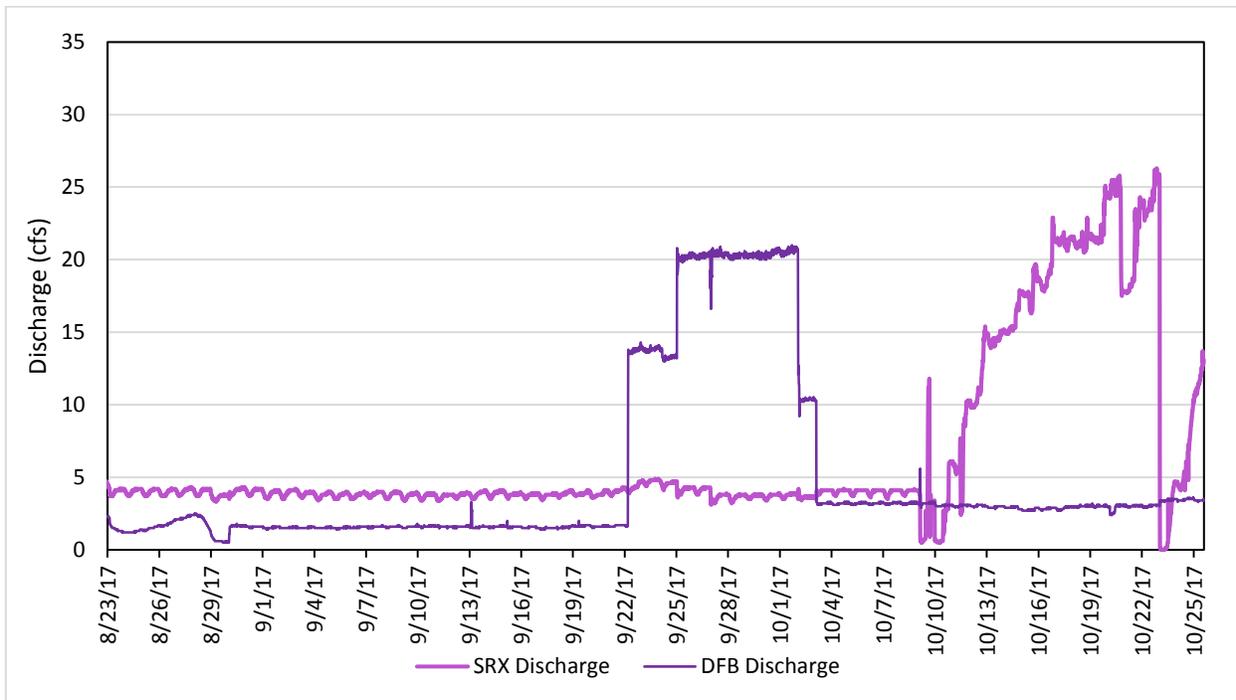
FIGURE 9. DWINNELL RESERVOIR/DAM FLOW RELEASES MEASURED AT CROSS CANAL (SRX) AND DWINNELL FISH BYPASS (DFB) (RETRIEVED FROM CDEC, 2017).

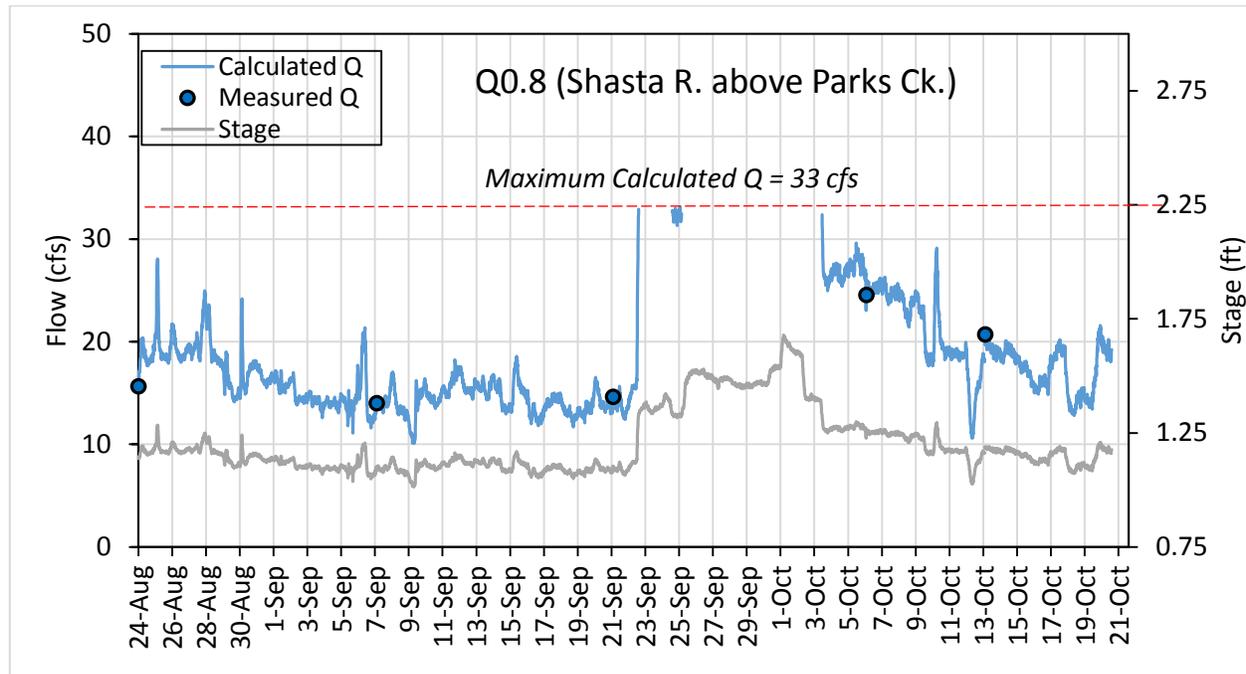
FIGURE 10. STAGE, MEASURED FLOW (Q), AND CALCULATED FLOW (Q) FOR Q0.8 DURING THE STUDY PERIOD. MISSING VALUES IN HYDROGRAPH EXCEEDED MEASURED VALUES USED TO CREATE RATING CURVE.

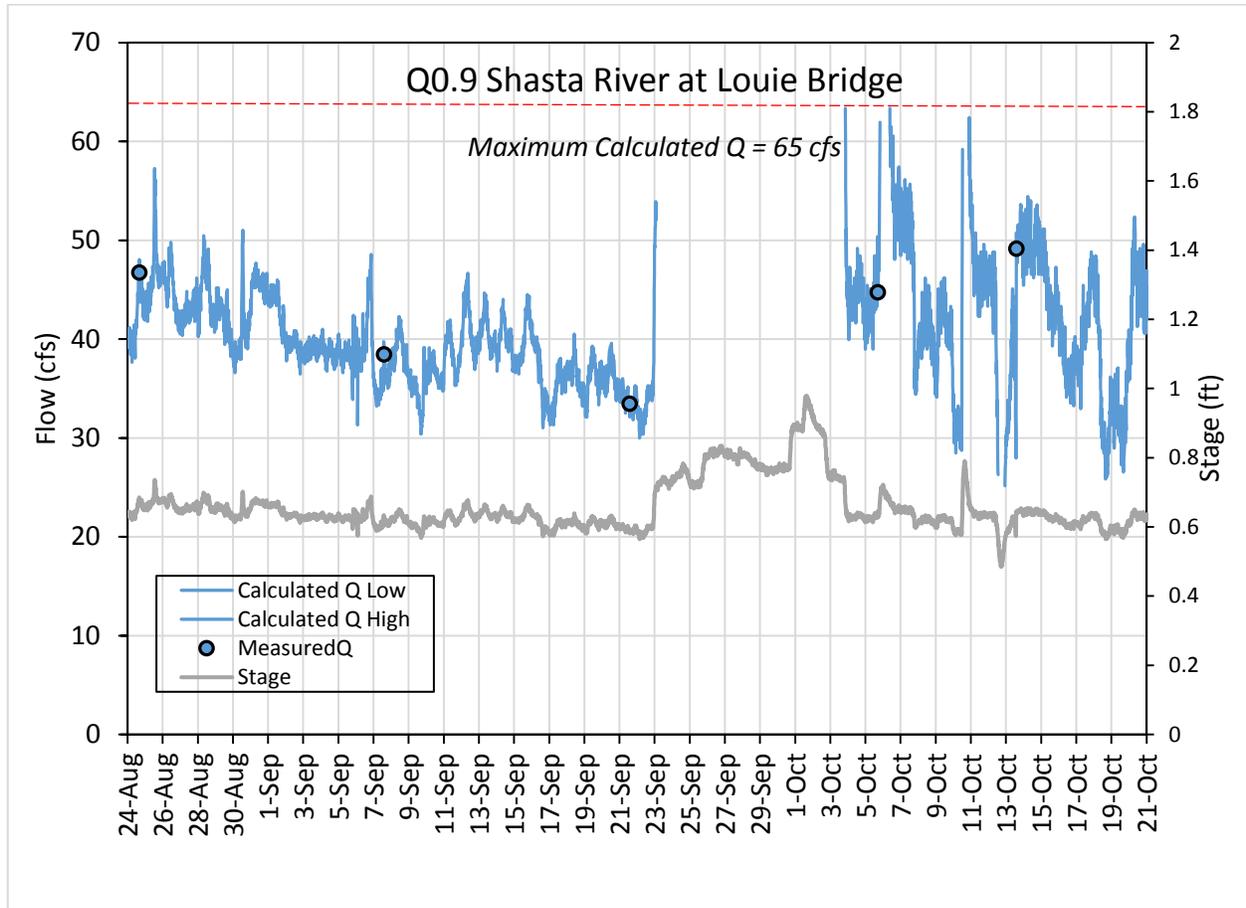
FIGURE 11. STAGE, MEASURED FLOW (Q), AND CALCULATED FLOW (Q) FOR Q0.9 (LOUIE BR.) AUGUST 24TH THROUGH OCTOBER 20TH, 2017. RATING CURVE WAS SPLIT INTO SEPARATE “HIGH” AND “LOW” CURVES DUE TO CHANGES IN CHANNEL MORPHOLOGY THAT OCCURRED DURING THE STUDY. THESE CHANGES LED TO A POOR FITTING (LOW R² VALUE) RATING CURVE. LOW VALUES FALL ON THE CURVE PRIOR TO SEPTEMBER 23. HIGH VALUES FALL ON THE CURVE AFTER OCTOBER 3RD. VALUES IN BETWEEN THESE DATES EXCEEDED MEASURED VALUES USED TO CREATE RATING CURVE AND THEREFORE REMOVED.

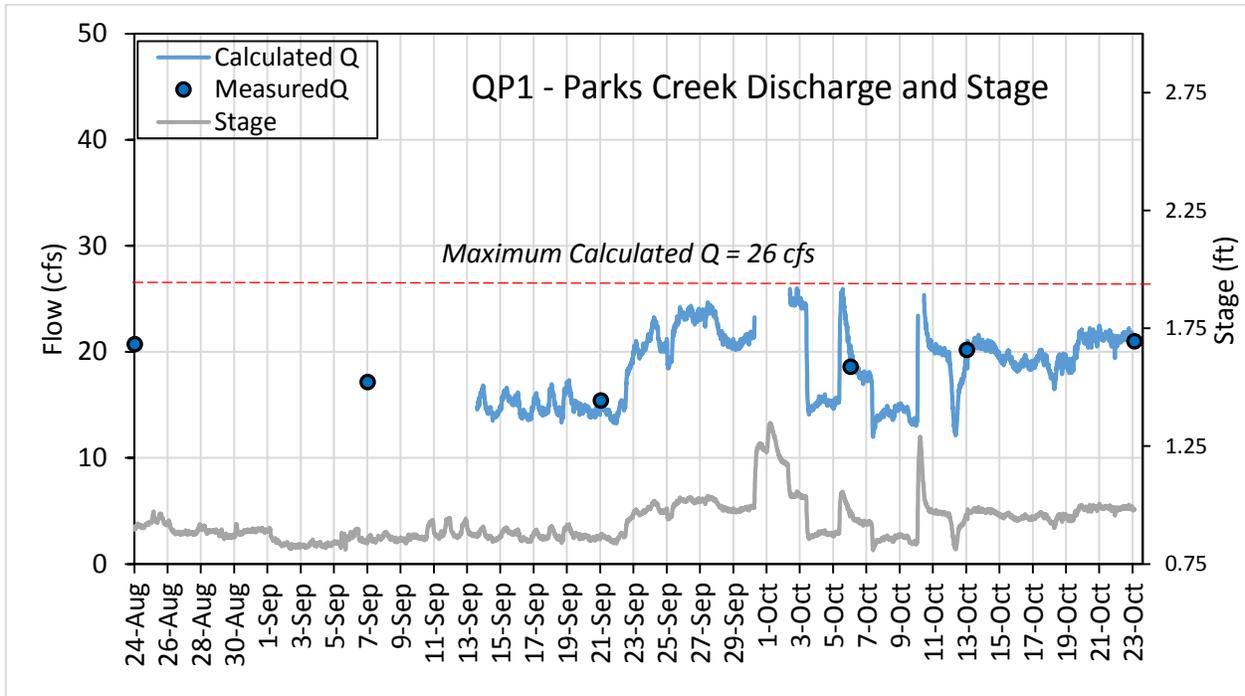
FIGURE 12. STAGE, MEASURED FLOW (Q), AND CALCULATED FLOW (Q) FOR QP1-PARKS CREEK ABOVE SHASTA RIVER CONFLUENCE, SEPTEMBER 24TH THROUGH OCTOBER 24TH, 2017. RATING PRIOR TO SEPTEMBER 24TH NOT USED DUE TO POOR FITTING RATING CURVE.

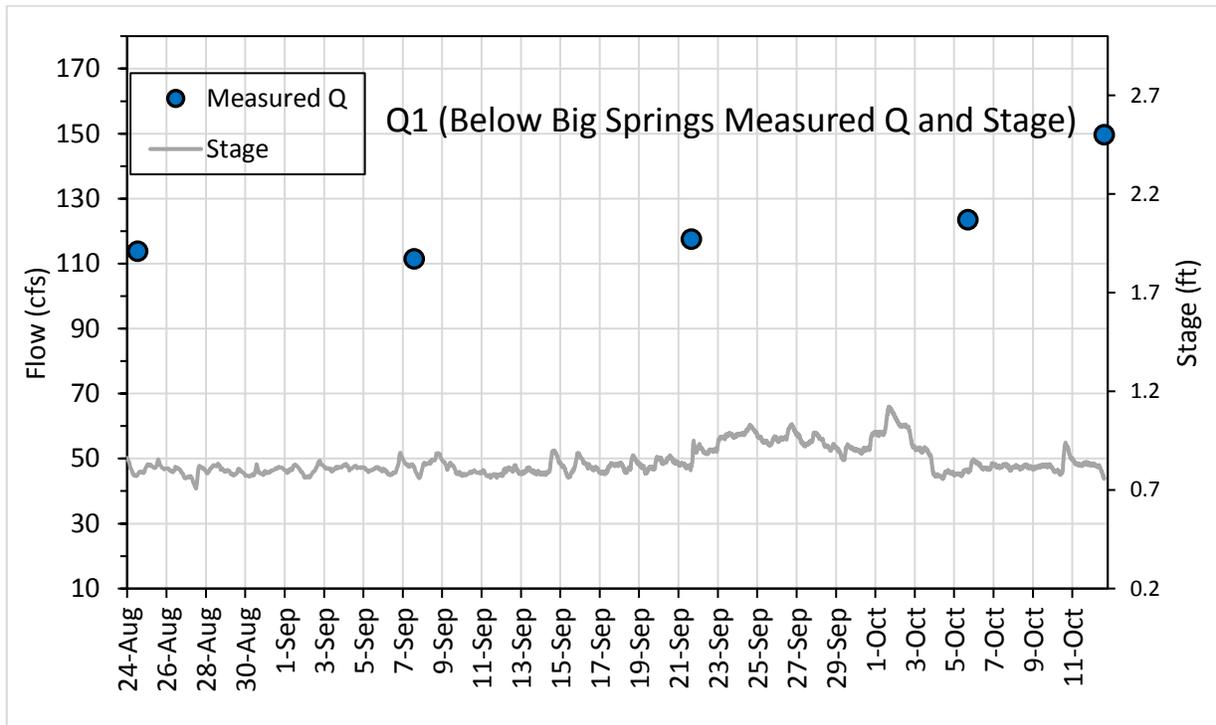
FIGURE 13. STAGE AND SINGLE POINT MEASURED FLOW (Q) FOR Q1 THROUGHOUT THE STUDY PERIOD.

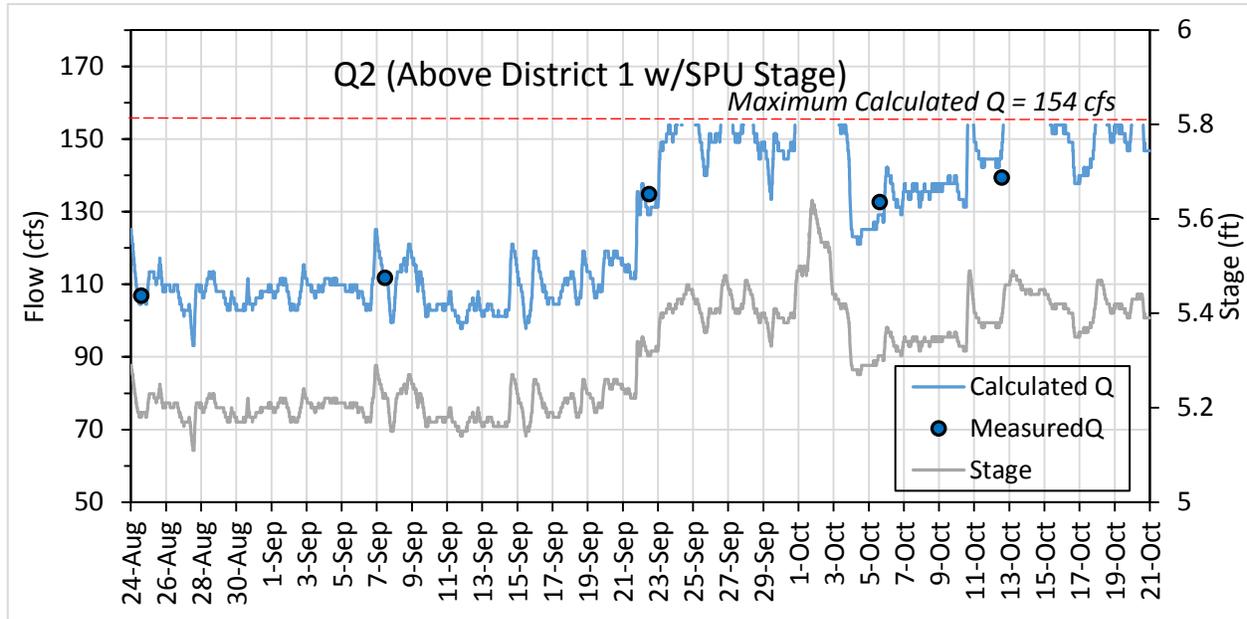
FIGURE 14. STAGE, MEASURED Q, AND CALCULATED FLOW (Q) FOR Q2 THROUGHOUT THE STUDY PERIOD. STAGE DATA RETRIEVED FROM CDEC (DWR STATION SPU).

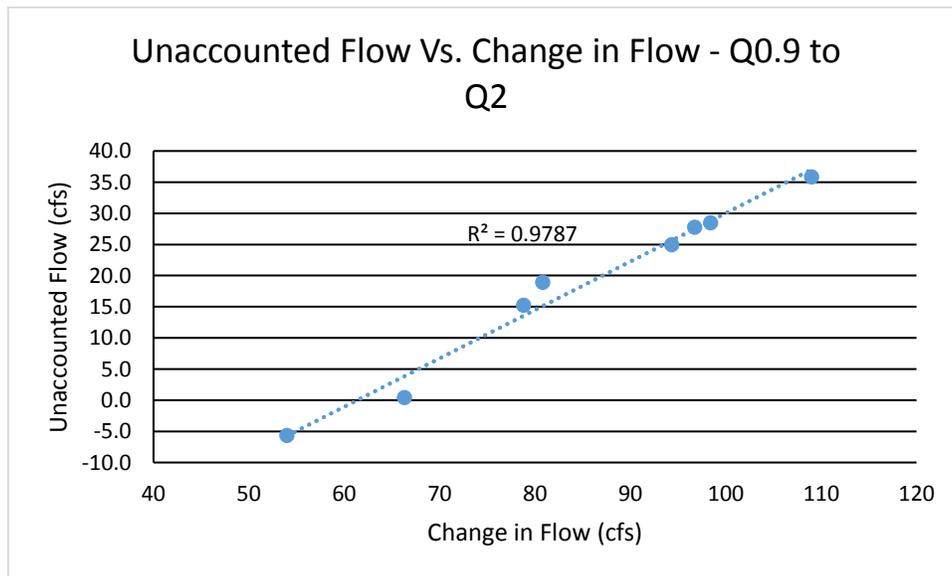
FIGURE 15. UNACCOUNTED FLOW (CFS) VS. CHANGE IN FLOW (CFS) IN REACH 1 BETWEEN Q0.9 AND Q2.

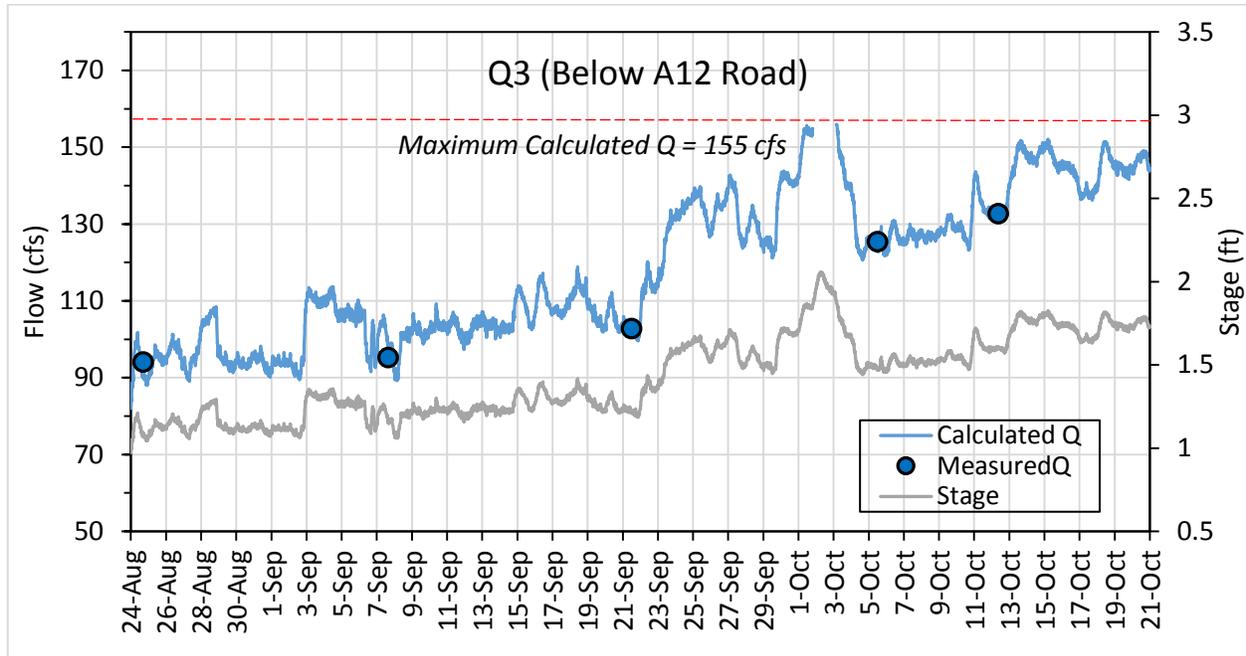
FIGURE 16. STAGE, MEASURED FLOW (Q), AND CALCULATED FLOW (Q) FOR Q3 THROUGHOUT THE STUDY PERIOD.

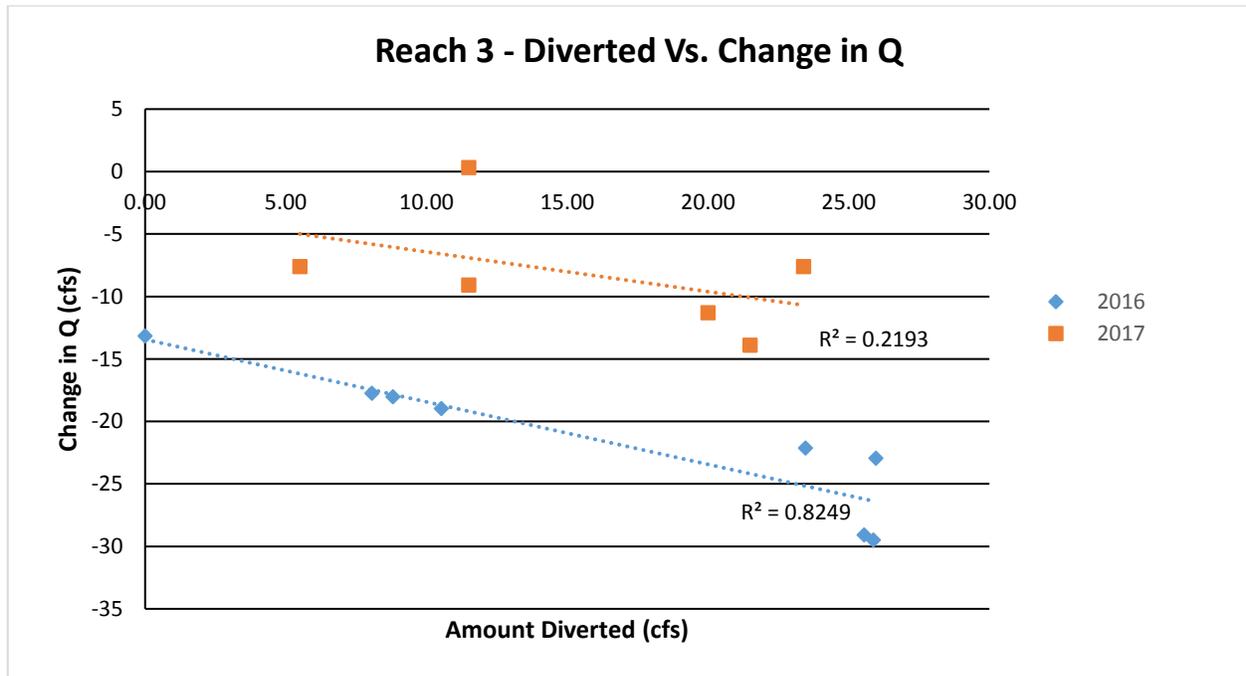
FIGURE 17. DIVERTED FLOW VS. CHANGE IN FLOW IN REACH 3 (Q2 – Q3).

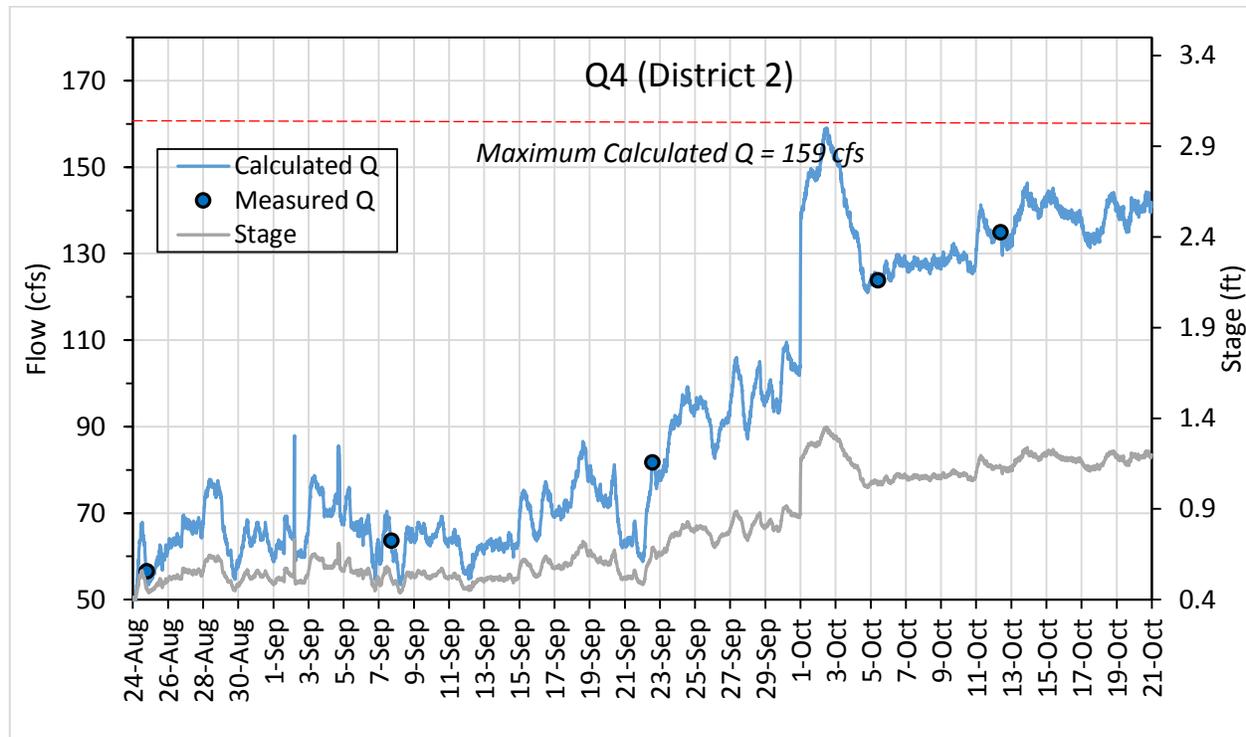
FIGURE 18. STAGE, MEASURED FLOW (Q), AND CALCULATED FLOW (Q) FOR Q4 THROUGHOUT THE STUDY PERIOD.

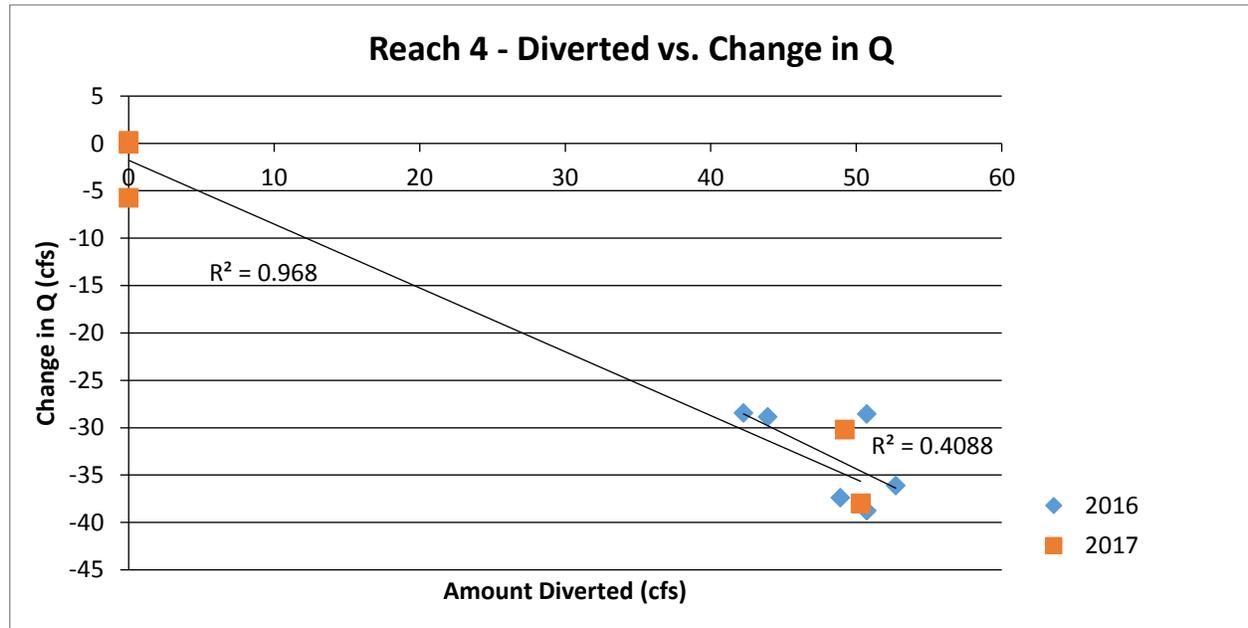
FIGURE 19. DIVERTED FLOW VS. CHANGE IN FLOW IN REACH 4 (Q3 TO Q4).

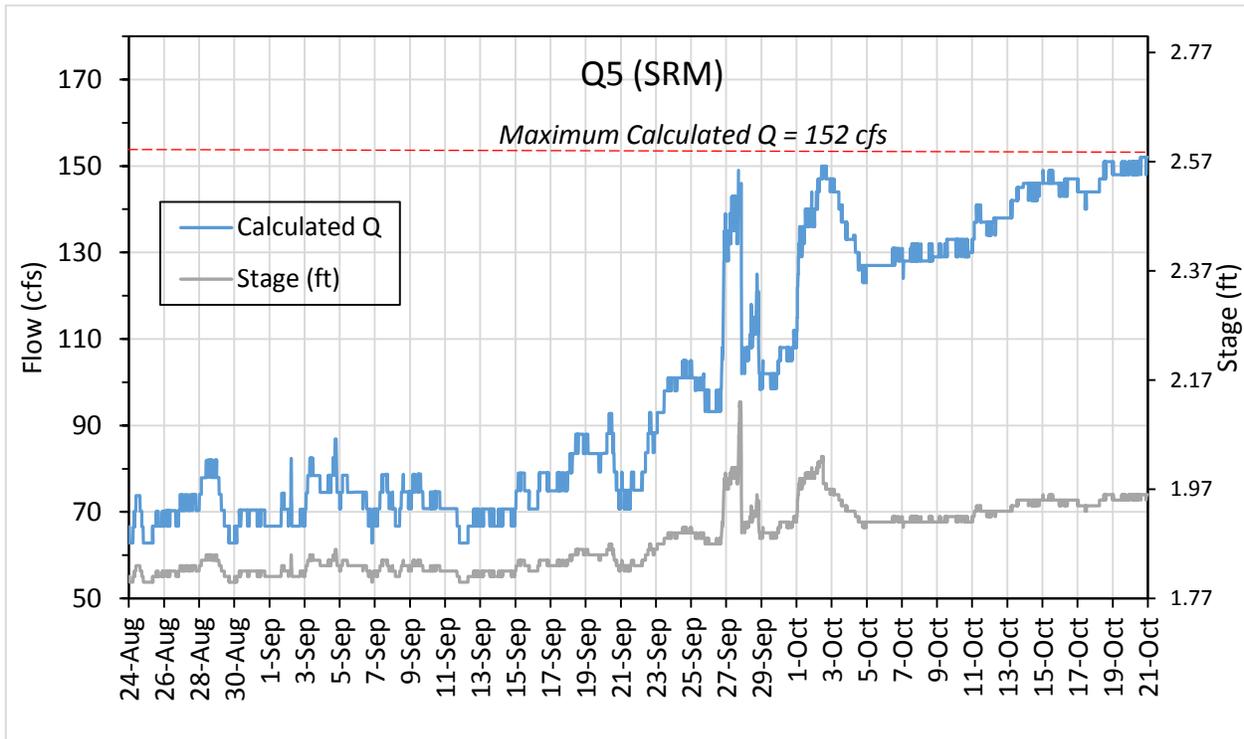
FIGURE 20. STAGE, MEASURED FLOW (Q), AND CALCULATED FLOW (Q) FOR Q5 THROUGHOUT THE STUDY PERIOD. THIS SITE IS MAINTAINED BY USGS. DATA WAS RETRIEVED FROM CDEC, 2017.

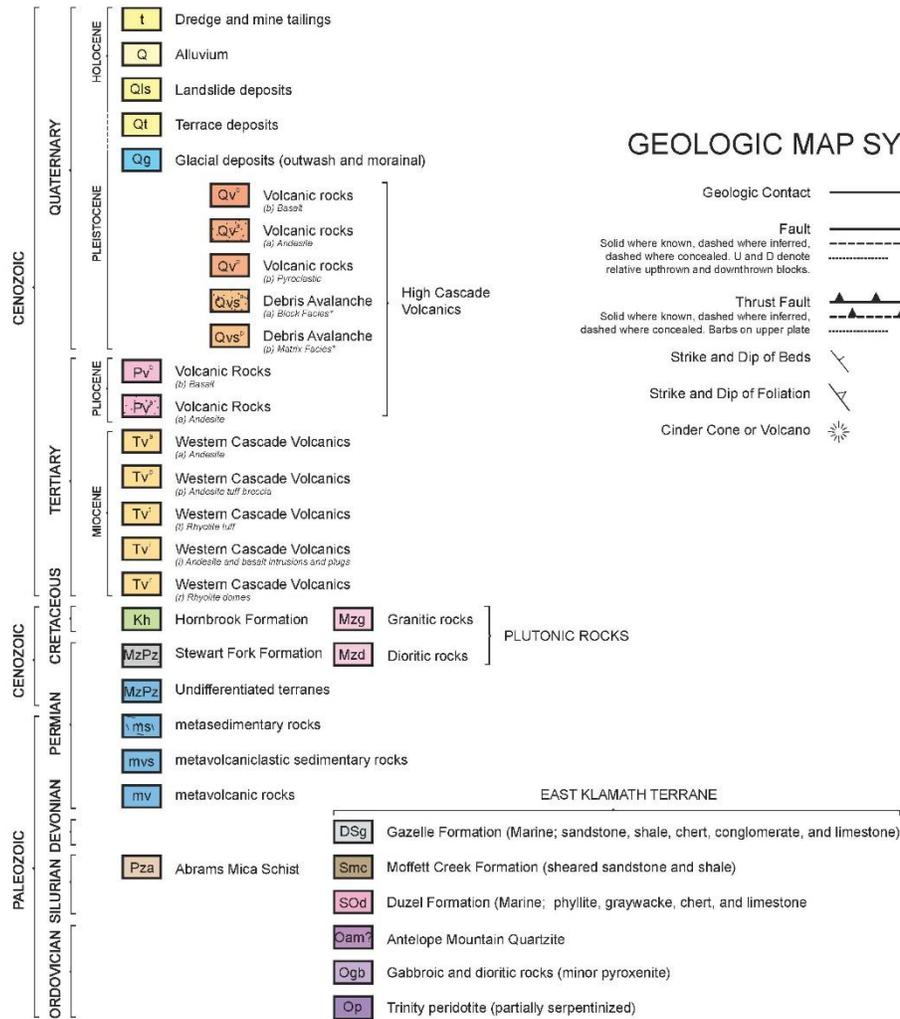
EXPLANATION OF THE GEOLOGY OF THE SHASTA RIVER WATERSHED		
	February 1, 2018	PROJECT NAME: 2017 Flow Study Phase II	
	SCALE: n/a	DRAFTED BY: EB	APPENDIX A2

Note: This explanation is taken from the Geologic Map of the Weed Quadrangle, California; D.L. Wagner and G.J. Saucedo; 1987; 1:250,000. This explanation is adapted to reflect the geologic units that occur within the Shasta River watershed boundary. *Explanations of volcanic rocks have been changed to reflect modern interpretations.
